## The Service Line

**Bill Carns - N7OTQ**

### **IS YOUR 75A-4 SMOKING MORE AND ENJOYING IT LESS ?**

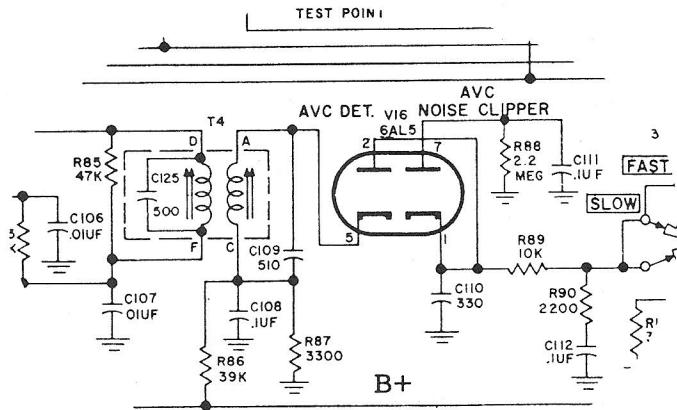
The culprit is a "smoking" R86, the 39K ohm 1/2 watt resistor used with R87 as a voltage divider from the B+ line to ground to develop the cathode bias level of 13-14 volts for the 6AL5 AVC rectifier V16. This positive bias of 13-14 volts on the cathode provides noise immunity for the AVC IF/detector chain and is very critical in providing stable and proper AVC and S-meter operation.

**Figure 1. Schematic of AVC detector section showing cathode bias voltage divider R86 & R87.**

Referring to Figure 1, and using a conservative normal B+ level of 155V for the receiver running on a 110V line ("operate" position), the dissipation in R86, the 39K resistor, is calculated to be:

or almost exactly 1/2 watt.

Since the 50's when the venerable 75A-4 was designed, the nominal line voltage has changed from 110V to 120 or 125V, and on long lines or with high line tolerance, it can get even worse. With a line voltage of 120V, the B+ level will typically be 170 volts in the "operate" position, but note that it rises to 190 volts when the radio is in "standby" and there is less load on the power supply.

With the B+ voltage at 190 volts and R86 at its tolerance limit, R86 can be dissipating over .8 watt.

The symptoms of the resulting failure of R86, and sometimes R87 (if R86 goes low in value), are:

1. dramatically changed AVC threshold and action, and
2. inappropriate or unstable S-meter reading.

It is recommended that, regardless of condition, R86 be replaced with a 39K +/- 5%, 1 watt minimum, carbon resistor. A 2 watt is preferred as it is more conservative.

At the same time, check R87 to make sure it is within tolerance (3.3K +/- 5%). The 1/2 watt rating here is more than adequate. If R87 is out of spec, replace it also. The resulting voltage on the cathode of the 6AL5 (V16) should be approximately 14 volts with the correct value R86/R87 and the radio in the "operate" position.

The new R86 can be placed, as it was originally, under and behind C109 and allowing enough lead length to clear the alignment tool access on T4.
