M300 REPAIR PROCEDURE

The purpose of this document is to assist authorized Lexicon Service technicians in repairing and updating returned units to current manufacturing standards. This and its associated procedures are the factory repair standard and are recommended to authorized distributor service centers. This procedure is to be used in conjunction the product service manual, technical bulletins and with standard performance verification, troubleshooting and QC procedures. Some of the information contained herein may be proprietary in nature and should be treated by Lexicon and its representatives as such.

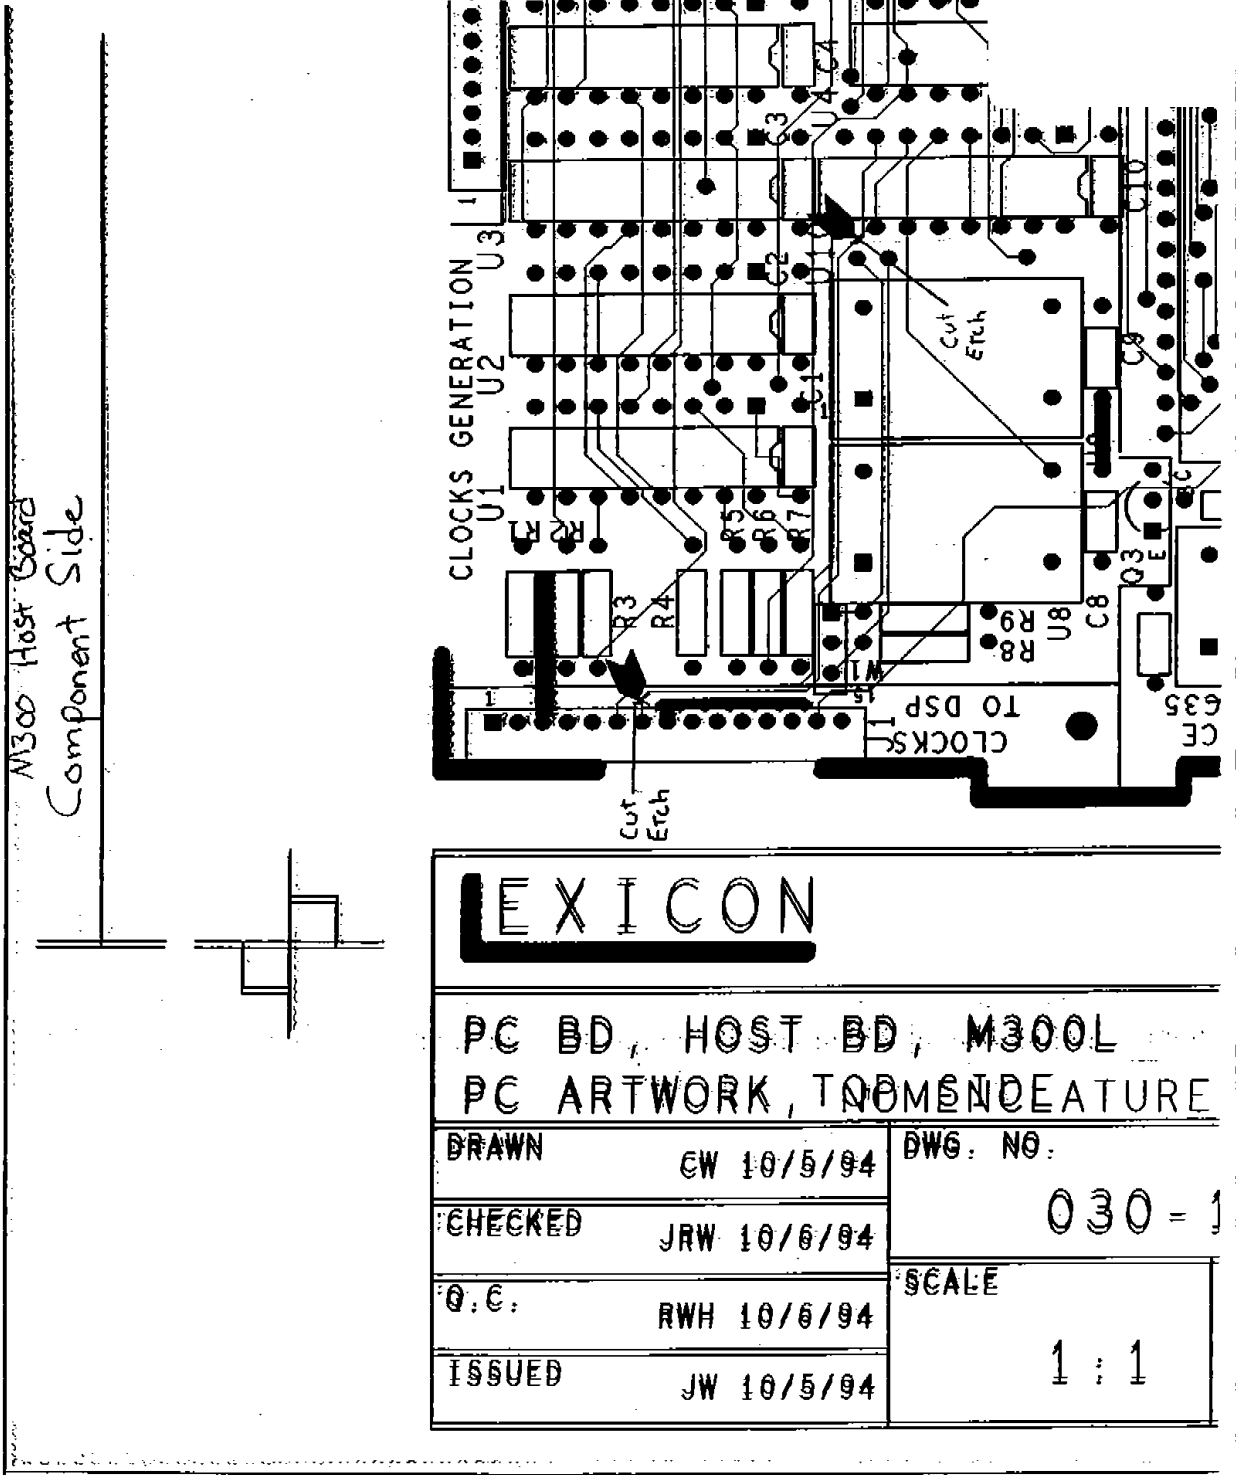
Note - Step 3 not required for new DSP Board builds

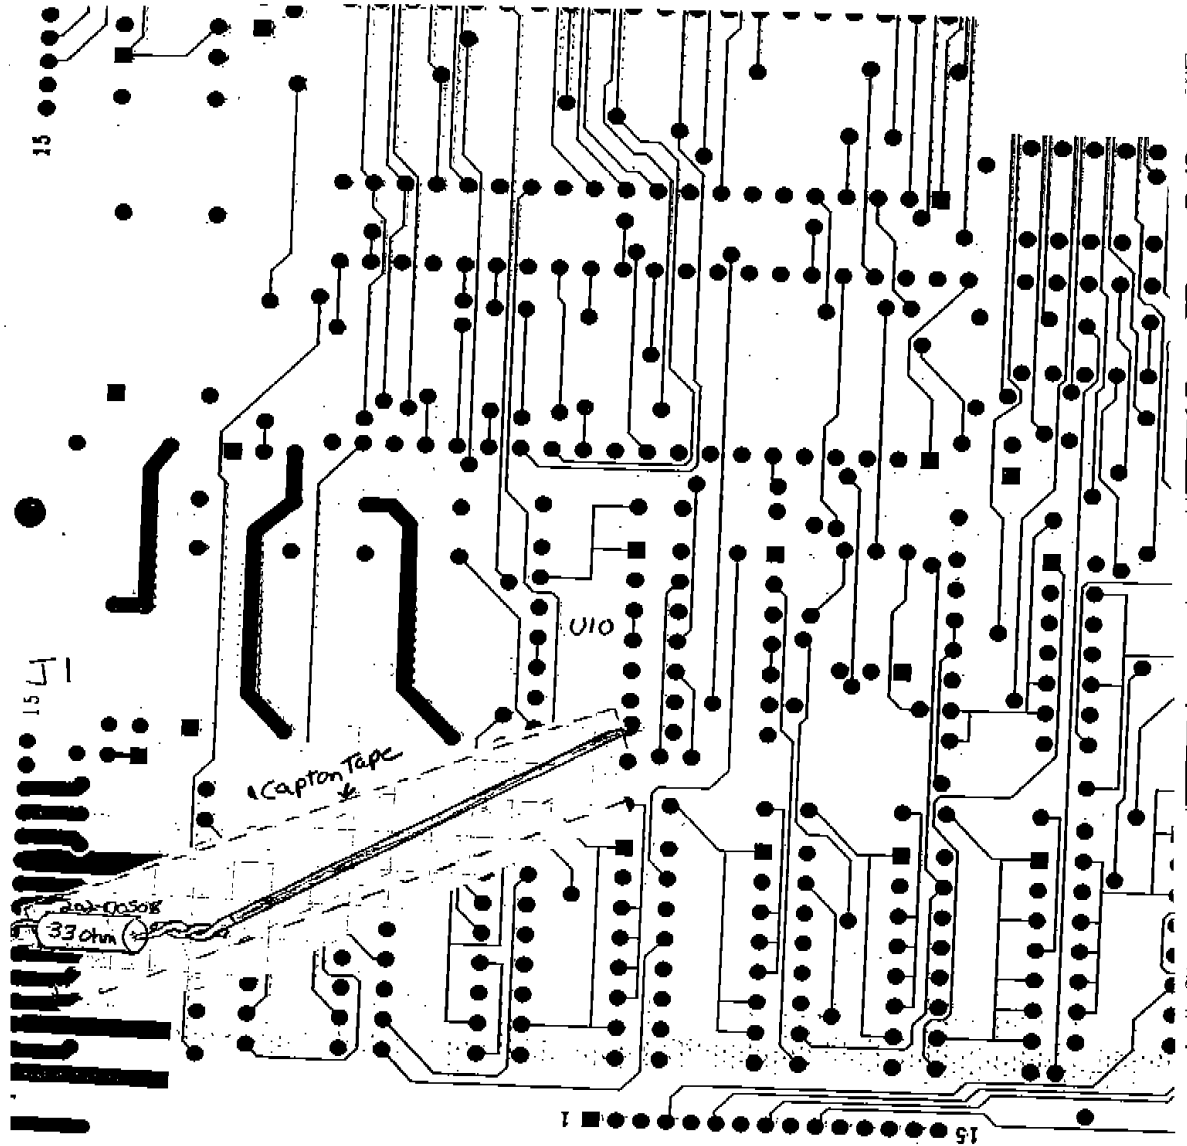
Host Board Solder Side

710-10780 Rev 0 PC BD,HOST,M300L
