## Bulletin 001: Flextone HD

## Bulletin 02: Flexitone II

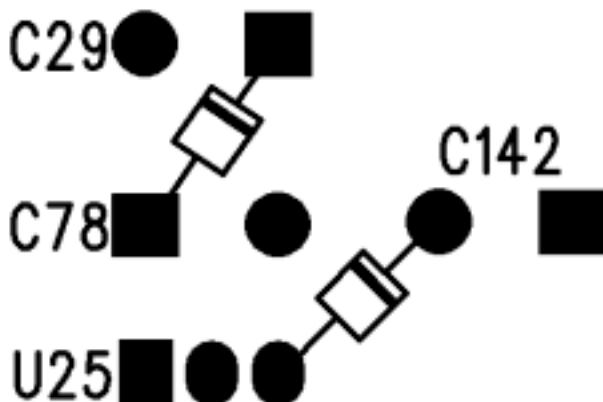
## Bottom side view of PCBA

**Indications :** Unit occasionally does not fully boot up. (Unit will power up and show input signal but will have no audio output).

**Repair Procedure** Add one 1N4002 (06-04-4002) diode at each of the outputs of the +/- 15V regulators. (See diagram below)

1. Place unit upside down with the back panel facing you.
2. Remove bottom cover of chassis.
3. Clip leads on two 1N4002 diodes (06-04-4002), keeping the leads as short as possible.
4. Solder diode from pin#1 of C78 to pin#1 of C29. Cathode side of diode connects to C29. (See diagram below)
5. Solder diode from pin#3 of U25 to pin#2 of C142. Cathode side of diode connects to C142. (See diagram below) (U25's pins are located approximately 3<sup>1</sup>/<sub>2</sub>" from the right side of the PCB and 2<sup>1</sup>/<sub>4</sub>" from the back side of the PCB (the side with the output jacks.)
6. Carefully check that both diodes are oriented correctly.

1N4002 Diode  
Anode—

—Cathode

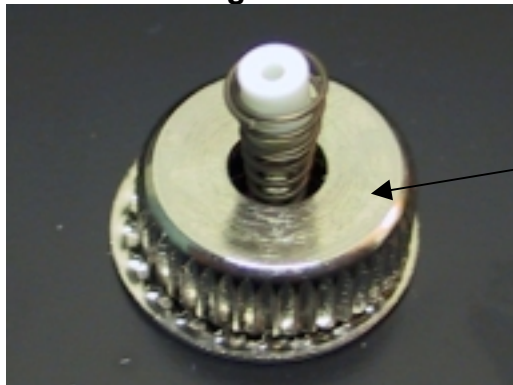
**Fig 1.**

**Indications:** Switches failing due to insufficient spring force from actuator to the tact switch, resulting in intermittent or non-operation of the switches.

**Repair Procedure :** Remove bottom plate of floorboard by removing the 6 screws on the bottom and the 2 screws on each side. Remove the bottom plate. Remove the 6 screws that are holding the switch board (the largest of the 3 circuit boards) in place and move the board out of the way so as to expose the switch actuators. Check that all the actuator springs are properly situated. Insert spacer (part # 30-15-0009; see Fig. 1) into the center of each switch actuator. Replace PCB and bottom cover.

MAKE SURE THAT  
SWITCH CAP IS SECURED  
TIGHTLY.

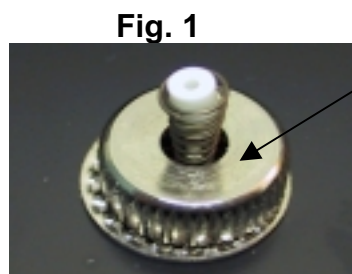
**Indications** : Switches failing due to insufficient spring force from the actuator spring to the tact switch, resulting in intermittent or non-operation of the switches.

**Repair Procedure** : Using 2 small flathead jeweler's screwdrivers or dental tools placed underneath the knobs and 180 degrees apart, gently pry off the 6 control knobs. It may be necessary to apply electrical tape to the screw drivers or dental tools to avoid chipping the paint off the perimeter of the knob wells. (A set of pliers can be milled concave to the circumference of the knobs by a machine shop to make the removal of these knobs easier. If interested, contact Line 6's service department for details). Remove nuts from the 1/4" jacks. Remove the 5 screws on the bottom plate. Remove bottom plate. Remove the five screws and the 1/4" hex standoff that secure the circuit board. Remove the circuit board so as to expose the switch actuators. Check that all the actuator springs are properly situated. Insert spacer (Part #30-15-0010) into the center of each actuator spring (see Fig. 1.) Replace circuit board, knobs, nuts and bottom plate.

MAKE SURE THAT SWITCH CAP IS SECURED TIGHTLY.

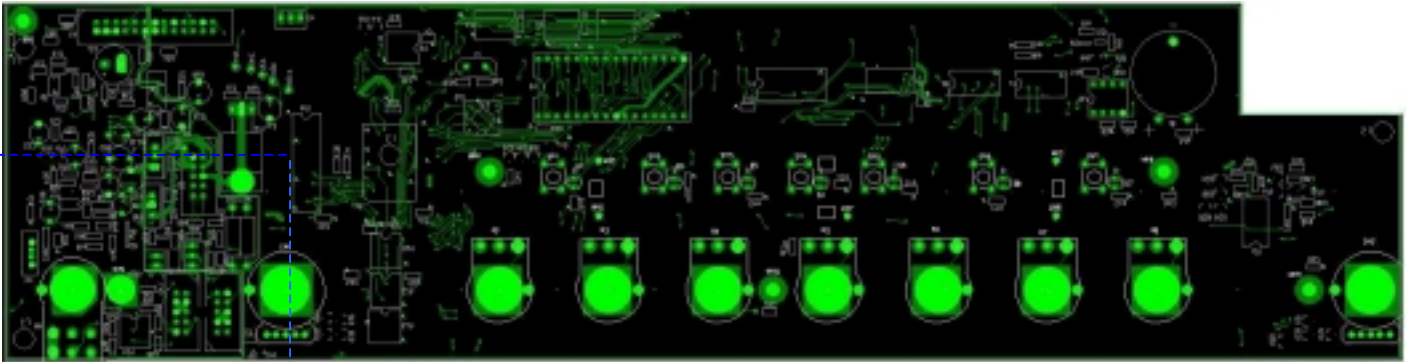
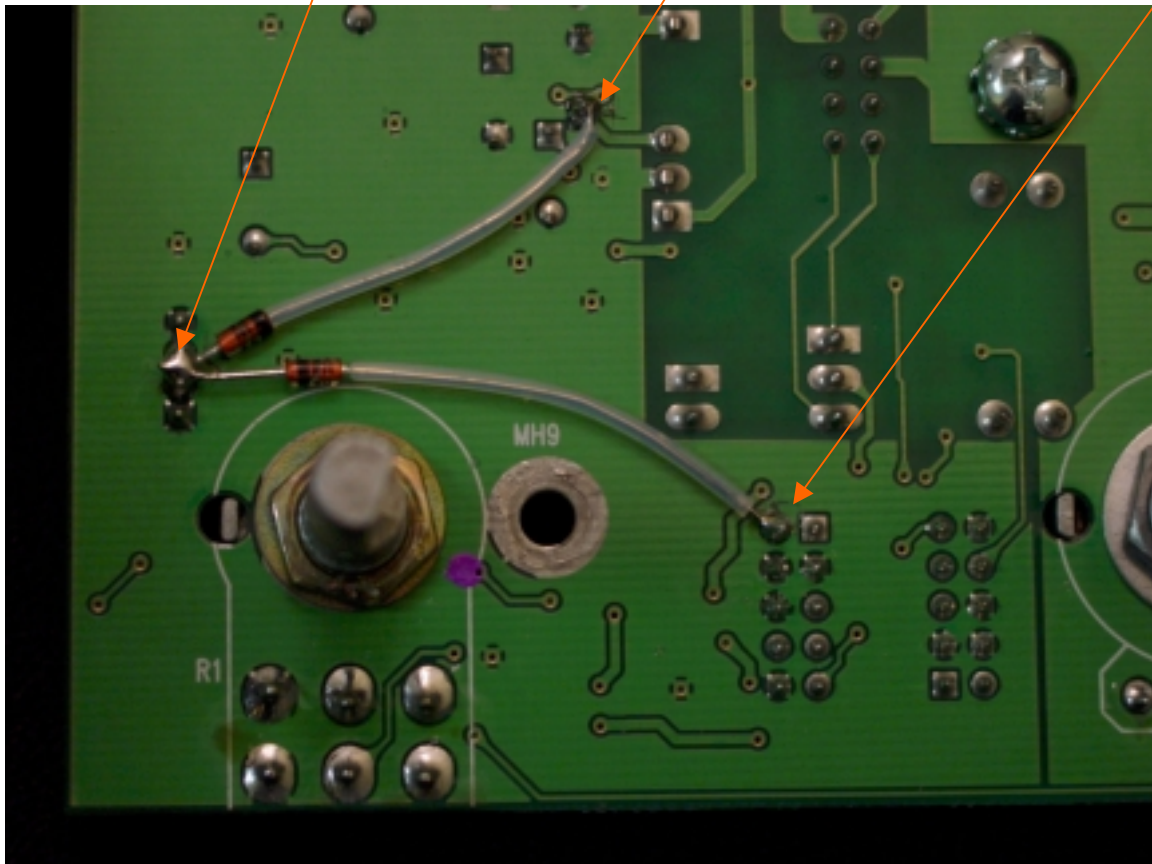
**Indications :** Distorted or no input signal due to electrostatic damage to U19 on Main board.

**Repair Procedure :** Disassemble amplifier head (see assembly instructions), remove main board. Install 1N4148 diodes as shown below.

**H9, pins 2&3**

KEEP DIODE LEADS VERY SHORT  
TO THIS CONNECTION

**H7, pin 2**

CONNECT ANODE OF  
LOWER DIODE HERE

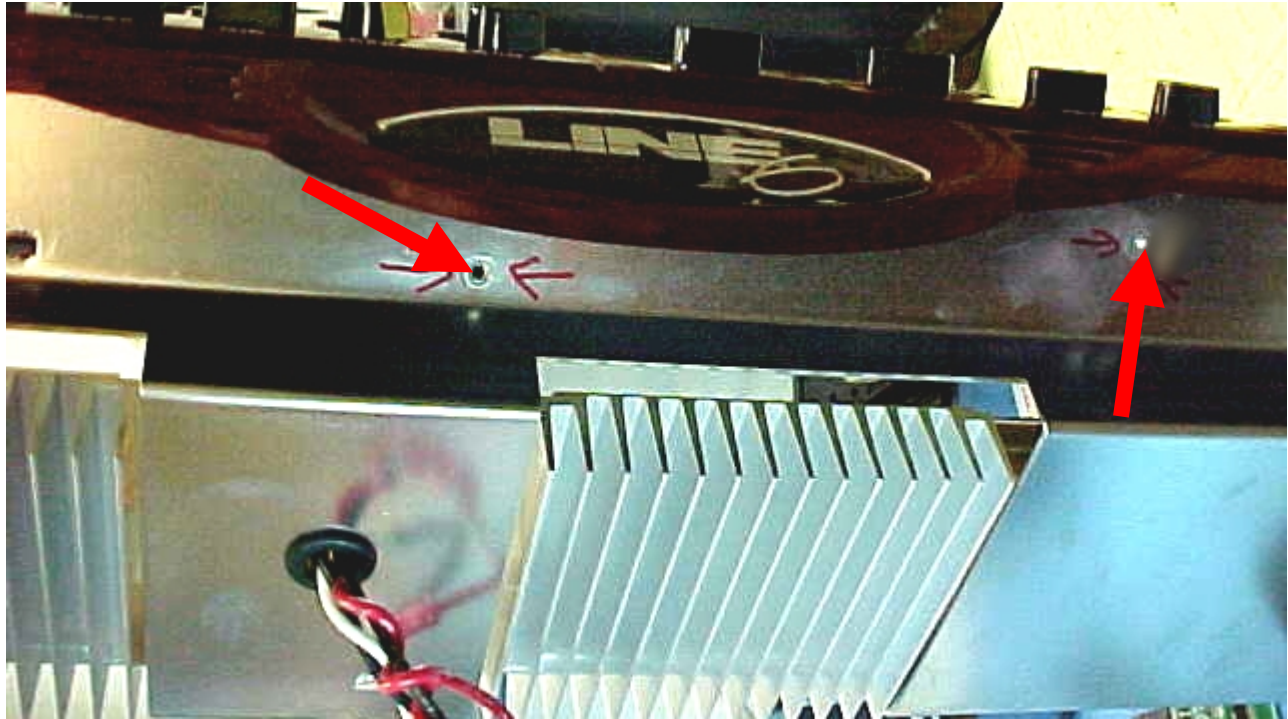
**Fig. 1**

**Indications :** PCBA flexing causing smt parts to crack or be compromised

**Repair Procedure :** Unplug speaker wires from speakers. (Note the arrangement in which they were wired). Unscrew the 4 screws on the top of the amp cabinet and remove metal amp chassis from cabinet. Be careful not to damage the faceplate as it hangs over the speaker baffle. Disconnect the 5 wires that come from the transformer's secondary winding as well as the 2 sets of speaker wires from the PCBA. Disconnect the ribbon cable that connects the front PCBA to the main PCBA. Remove Main PCBA by unscrewing input and headphone jack hex nuts and removing 3886 power amps from heatsinks. Slide the main PCBA out from under the front panel PCBA and remove from the chassis.
