Modifikation von Mikroprozessorkarten

Die Prozessorkarte 1.811.774.12 für das Gerät A812 kann mit dem Umbausatz 20.050.812.00 modifiziert werden.

Modification of microprocessor boards

For the processor card 1.811.774.12 used in the A812 recorder, modification kit 20.050.812.00 is required.

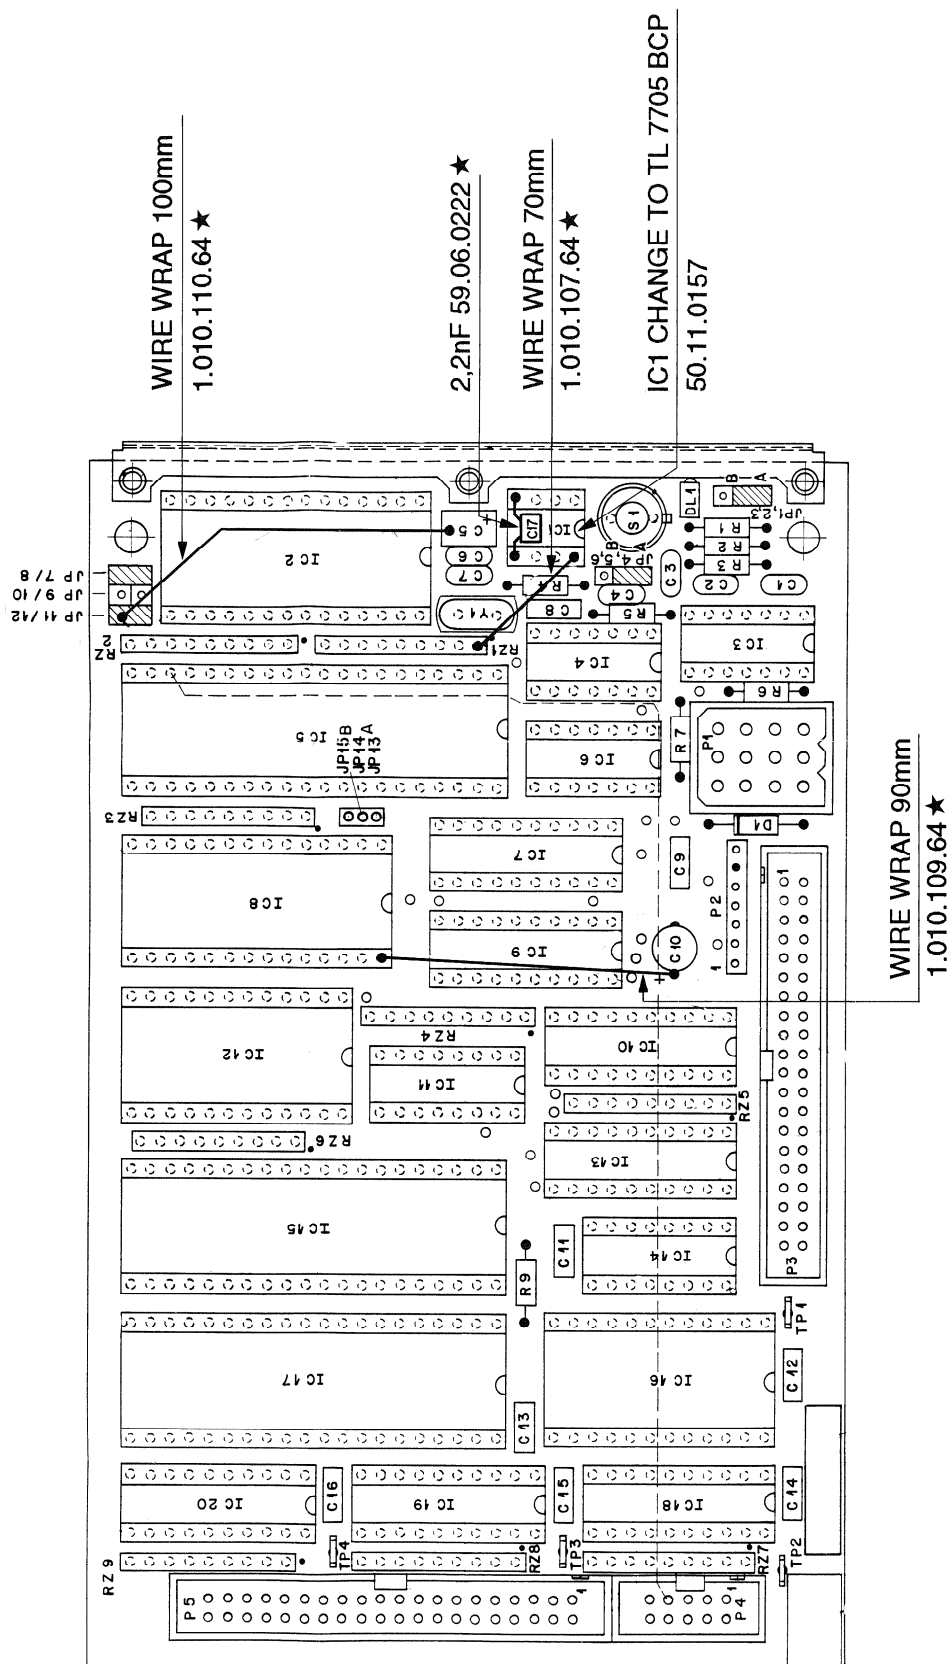
1.811.774.12

Diese Modifikation behebt das Problem "Error, Data lost", entstanden durch zeitweise fehlerhaften Reset des Mikroprozessors beim Einschalten der Maschine. Sie soll dringend bei batteriegepufferten Karten durchgeführt werden.

This modification solves the problem "Error, Data lost", caused by occasional incorrect microprocessor reset during the "power on" routine. The alterations listed below are of prime importance with battery buffered cards.

★ ON SOLDER SIDE
AUF DER LÖTSEITE

- IC 1, TL 7705 ACP entfernen, dafür neu TL 7705 BCP einsetzen.
- C 2,2nF zwischen PIN 4 und 5 von IC 14 einlöten.
- Wire-Wrap Draht l=100 von C5 (negativ) auf JS 12 (Masse).
- Wire-Wrap Draht l=70 von IC 1, PIN 8 auf PIN 1 von R21.
- Wire-Wrap Draht l=90 von C10 (positiv) auf PIN 28 von IC 8.
- Neues, um 1 erhöhtes Indexschild auf dem Beschriftungsstreifen anbringen.

- Replace IC 1, TL 7705 ACP with TL 7705 BCP
- Fit C 2,2nF capacitor between pin 4 and 5 of IC14
- Fit wrap-wire l=100 from C5 (negative) to JS 12 (shield)
- Fit wrap-wire l=70 from IC 1, pin 8 to pin 1 of R21
- Fit wrap-wire l=90 from C10 (positive) to pin 28 of IC 8
- Fit index label of next higher number to legend strip.
