Modification Power Distribution Board to avoid booting problems (symptom: fan doesn't start or ev. screens black)

Vista 5 Distribution Board 1.949.810.00

D21m Frame 1.949.405.82 LED/PSII Board with Power Supplies

D21m MADI HD Card 1.949.411.23 / 1.949.413.22

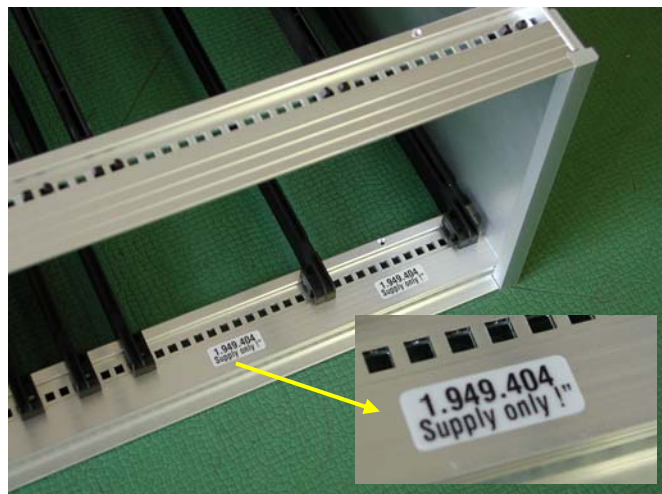
1.949.405.83 new type with
1.949.402.81 LED/PSII board
with warning label as indicated at right.

Note : When replacing a LED/PSII board, please make sure that the corresponding warning label in the rack is present. Spare/Replacement LED/PSII boards will be shipped with instructions and labels.

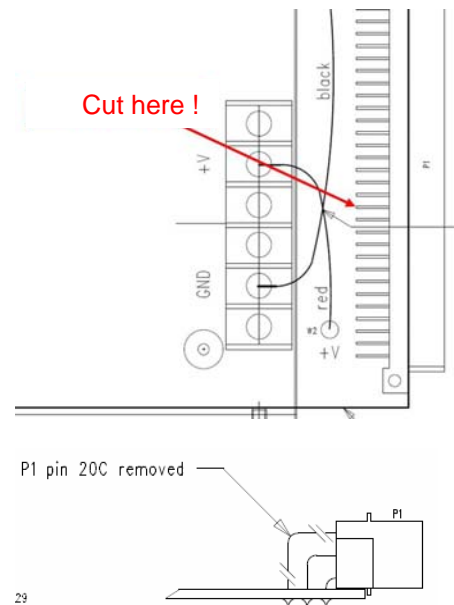
Modification 1.949.403.00 to revision "81"
(making 403 supplies ready for new D21 Racks)

- Cut Pin 20C of connector P1

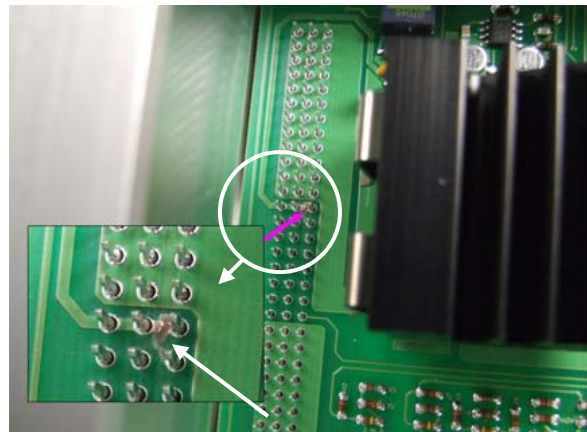
Modification 1.949.402.00 LED/PSII Board
for 89.20.1167 cables (15 pin 1:1)

Cut the track as indicated at right.

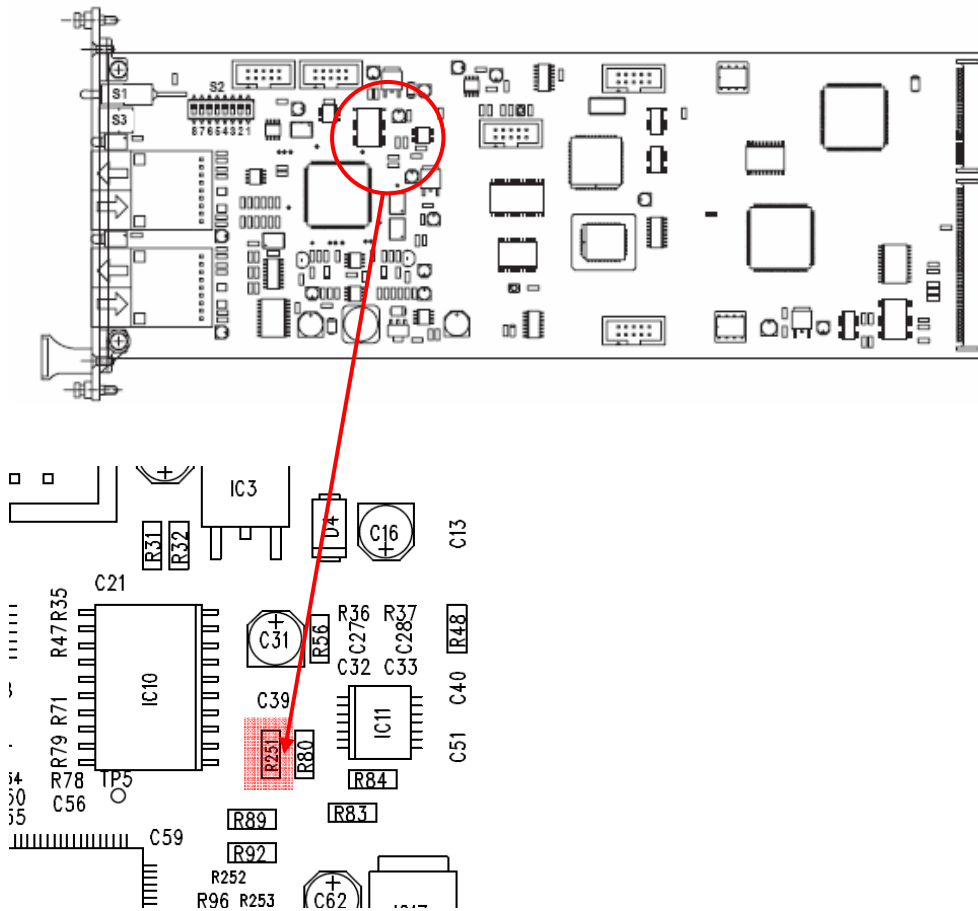
Problem : When more than 48 different audio signals are present on the MADI input, there was an increased jitter of the FS SYS signal measured on some cards. This caused the D21m stagebox not to work properly anymore (clicks on output channels)

Current boards which show the problem can be fixed by replacing R251 (33 ohms, Minimelf type) with 82 ohms (Studer order no 57.60.1820).

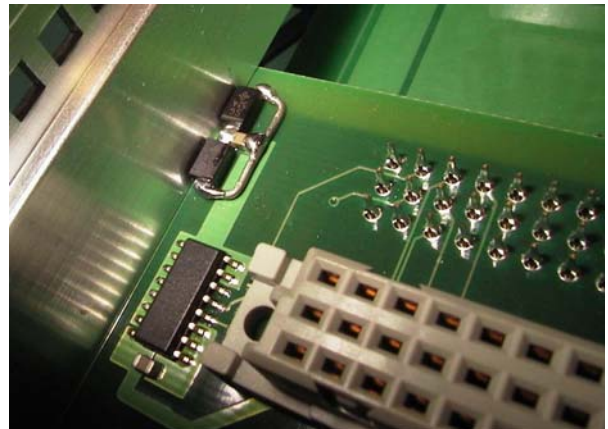
If a patch bay is implemented, GND (pin 1 on XLR connector) of each microphone input should be connected to its corresponding GND pin but not to CHASSIS. If CHASSIS instead of GND is used as negative reference for a microphone, it can occur that the GND net of the D21m is pulled towards -48V. This causes the HD-Link receivers on the HD card not to work correctly or to be damaged, depending on the type and number of microphones connected.

Solder antiparallel diodes
S1B (50.60.8003)
over C15 (a 15mm wire is optimal).

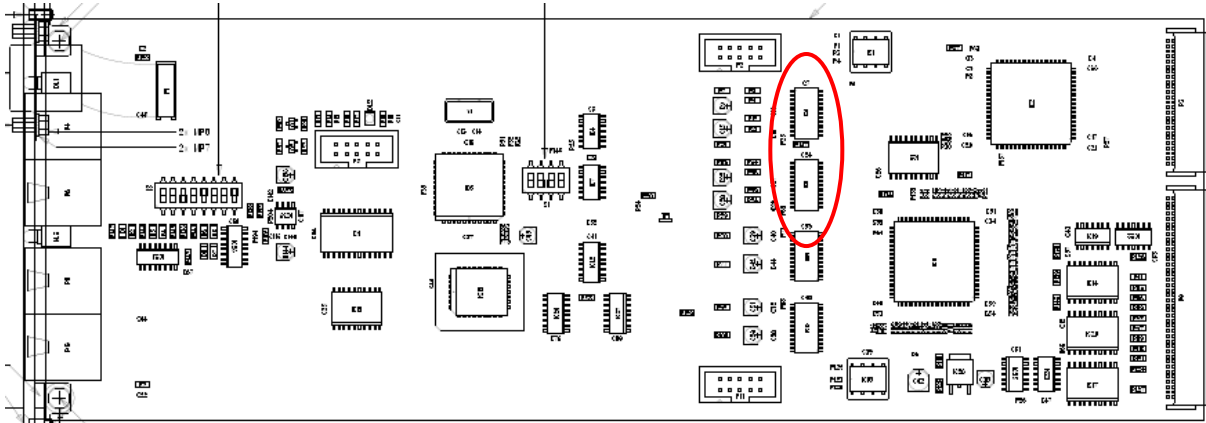
Analysis : If card inputs of a HD card 1.949.415 are damaged, it's typically the input stage of the LVDS receiver DS90CR216 (IC8, IC3 for IN1, IN2). As a result the input does no longer lock to an incoming signal (Lock LED stays dark), or the HD link becomes unreliable (see measurement below for verification)

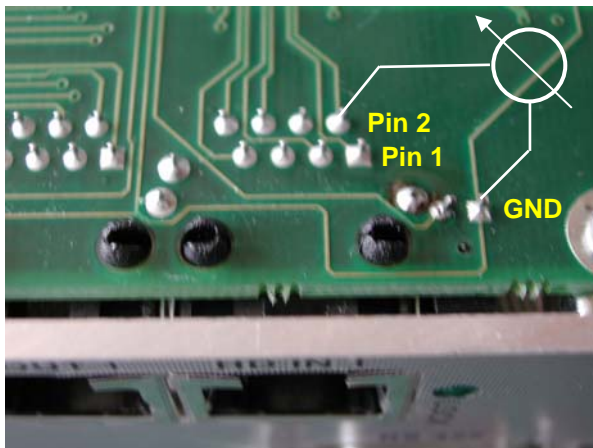
Defect receivers typically show different input impedance when measured to ground reference. Good inputs have high impedance (MOhm range), defect ones show often < 1kOhm (see example with measurement points for input 0 below) :

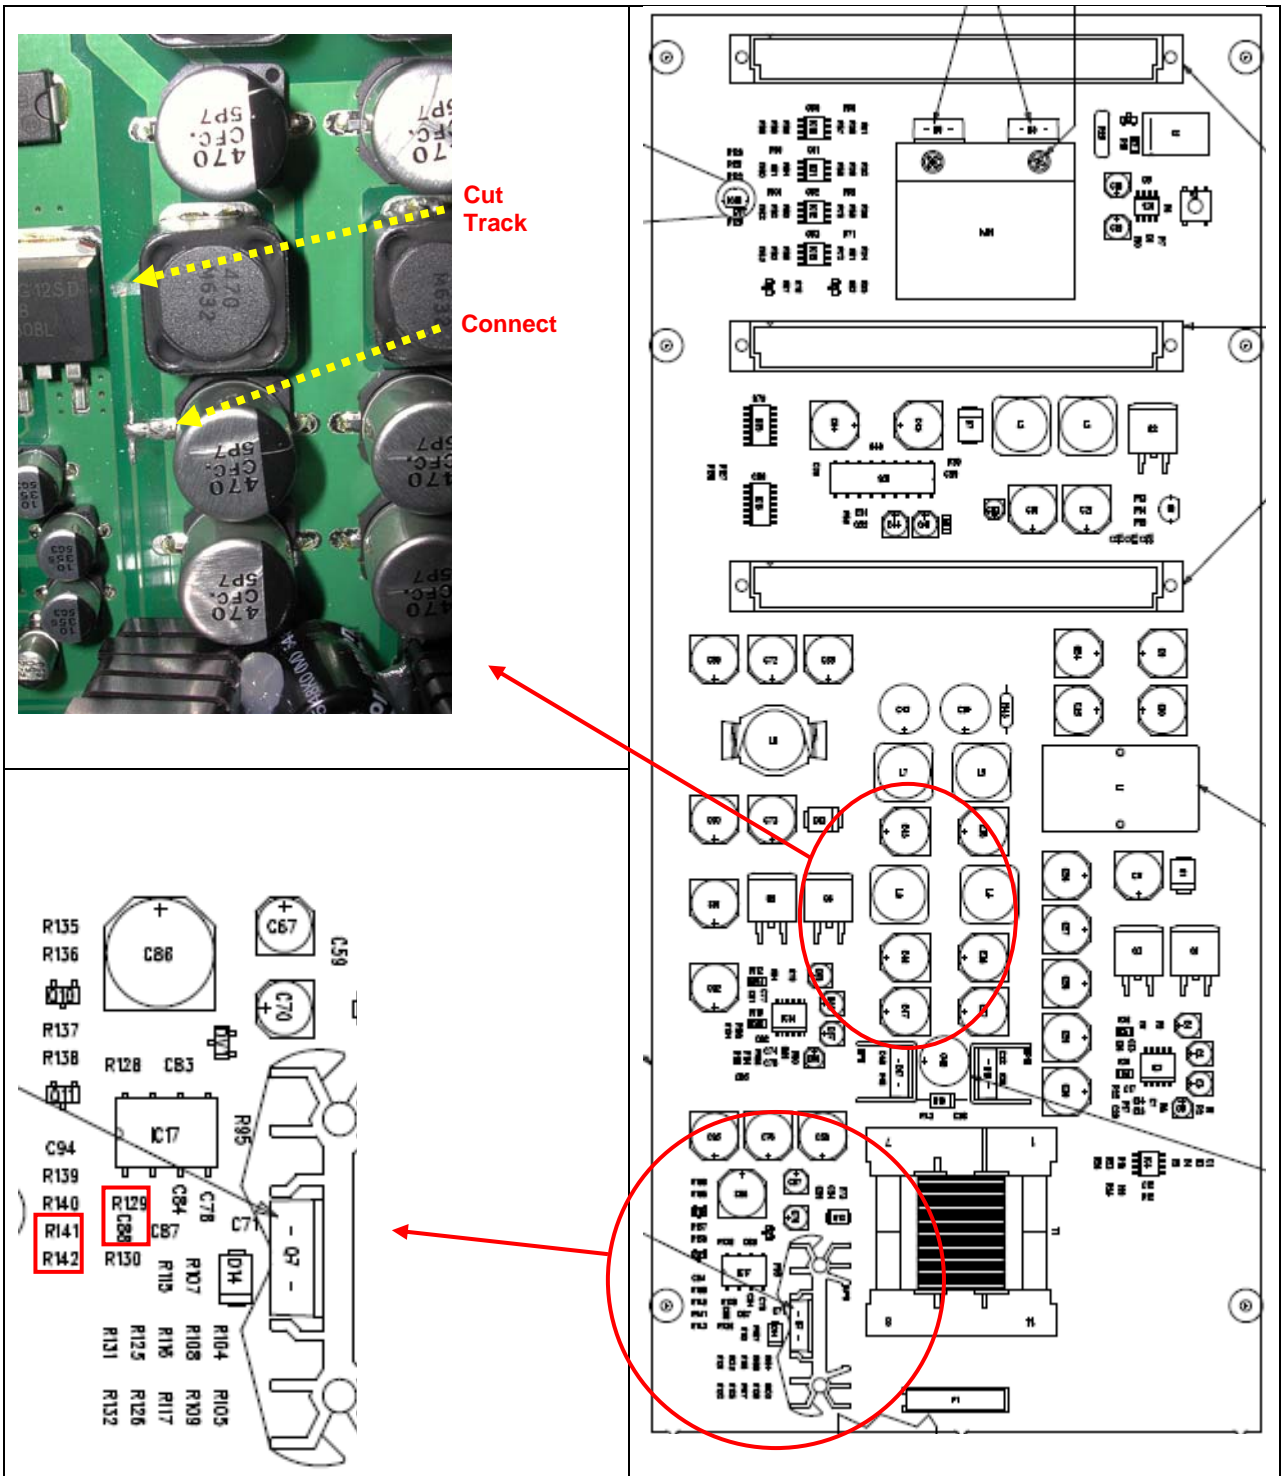
Depending on transformer and load of the supply, the $\pm 15V$ supply may become unstable (noise on analog I/O boards). The following revision "B" modification fixes the problem (in production since October 2005).

- The modification consists of
- C88 replace 1nF with 100pF (59.60.2349)
 - R129 replace 100k with 10k (57.60.1103)
 - R141 replace 2k with 300 Ohms (57.60.1301)
 - R142 replace 10k with 1k5 (57.60.1152)
- connect feedback signal to other side of L6 (to + of C46), see picture below
