TECHNICAL BULLETIN

MODEL/DERIVATIVE:
Defender

Bulletin N°: **0015**
CDS. ref: **L8622bu**
Issue: **1**
Date: **01.11.2000**

PROBLEM:
UNNECESSARY REPLACEMENT OF PAS FLUID RESERVOIR

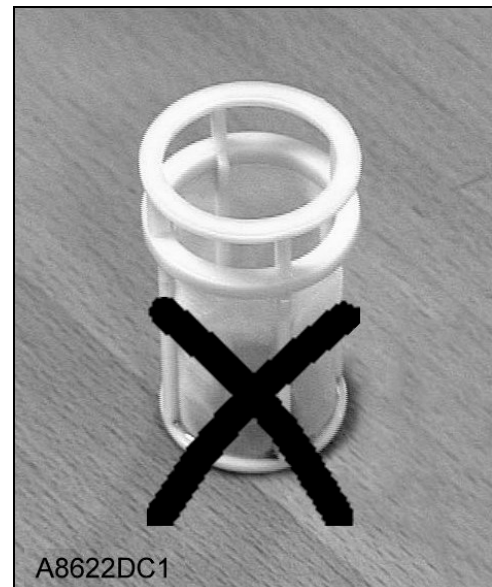
Power Assisted Steering (PAS) fluid reservoirs are being replaced as the result of the filler neck fluid filter not being fitted.

CAUSE:
At VIN YA 194718 the reservoir neck filter shown in the illustration was deleted.

This filter is not a specification requirement for Defender but was included in the component as supplied to Land Rover.

The supplier has now revised the reservoir supply condition and the filter is no longer included.

ACTION:
Ensure that all relevant staff are aware of this change and that it is clearly understood that PAS fluid reservoirs *MUST NOT* be changed for the condition described above.

The same change will apply to replacement fluid reservoirs supplied by Land Rover Parts. When existing stocks are exhausted, new reservoirs will be supplied without the neck filter.
