TECHNICAL BULLETIN

MODEL/DERIVATIVE:
Discovery II

Bulletin N°: 0086
CDS. ref: L8685bu
Issue: 1
Date: 19.12.01

PROBLEM:
KNOCKING / CREAKING NOISE FROM THE FRONT OF THE VEHICLE
Knocking / creaking noise when turning at slow speeds (predominantly steering from lock to lock).

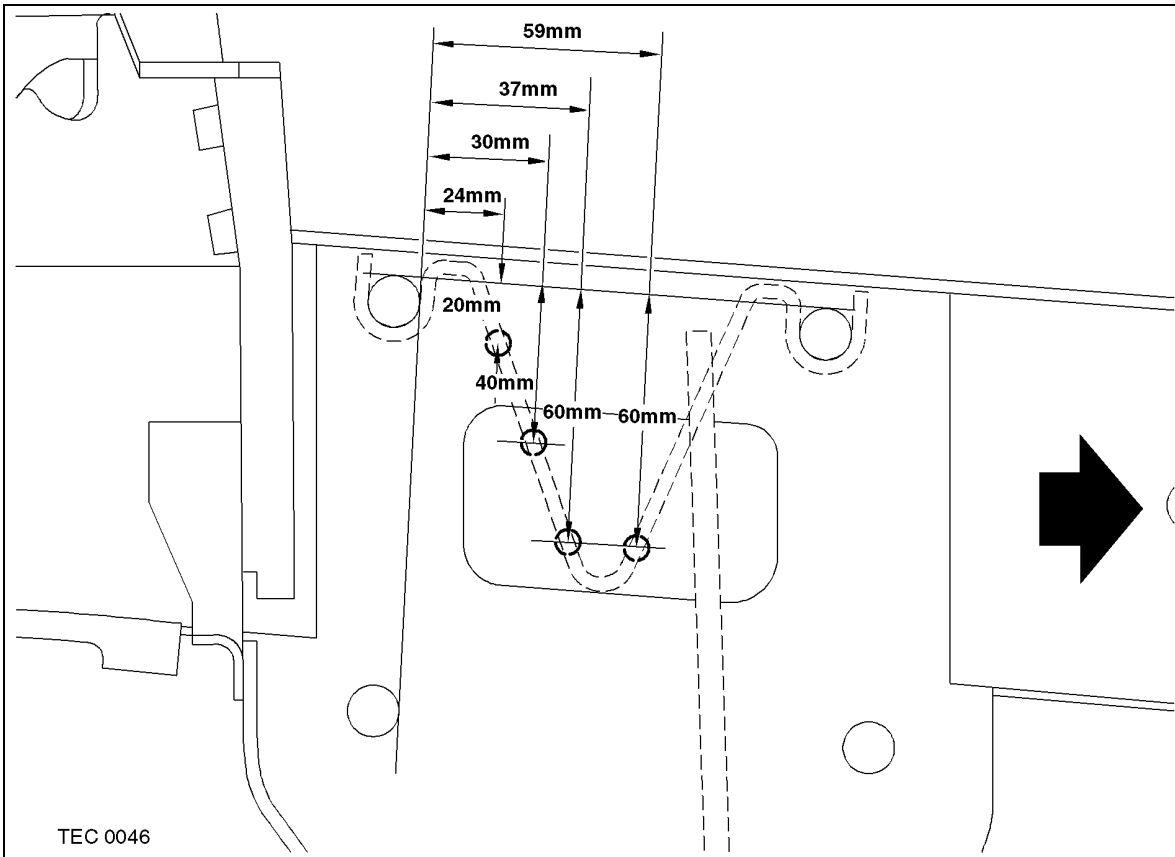
TEC 0046

CAUSE:
Movement of internal spacer in the front longitudinal chassis member where the Power Assisted Steering (PAS) box is located.

Right hand drive vehicle (Arrow points towards front of vehicle)

7. Flat bottom drill 4 holes 8 mm diameter at the positions marked, drill until internal spacer is exposed, the holes can be drilled to a maximum of 10 mm. Depth of the holes may vary.
CAUTION: If the spacer is not exposed, a further hole may have to be drilled to establish the position of the internal spacer.
8. Grind chassis to expose bare metal around the drilled holes.

9. MIG weld the edge of the internal spacer to the chassis, ensure spacer is fixed to the chassis before proceeding. Completely fill all holes with weld.
10. Grind excess weld material level with the chassis.
11. Etch prime bare metal, repair paint finish as required.
12. Refit steering box bolts and tighten to 90 Nm.
13. Refit anti-roll bar link, washer and nuts and tighten to 100 Nm.
14. Lower vehicle.
15. Refit the front road wheel on the drivers side and tighten nuts to 140 Nm.
16. Reconnect the alternator and the battery earth leads.

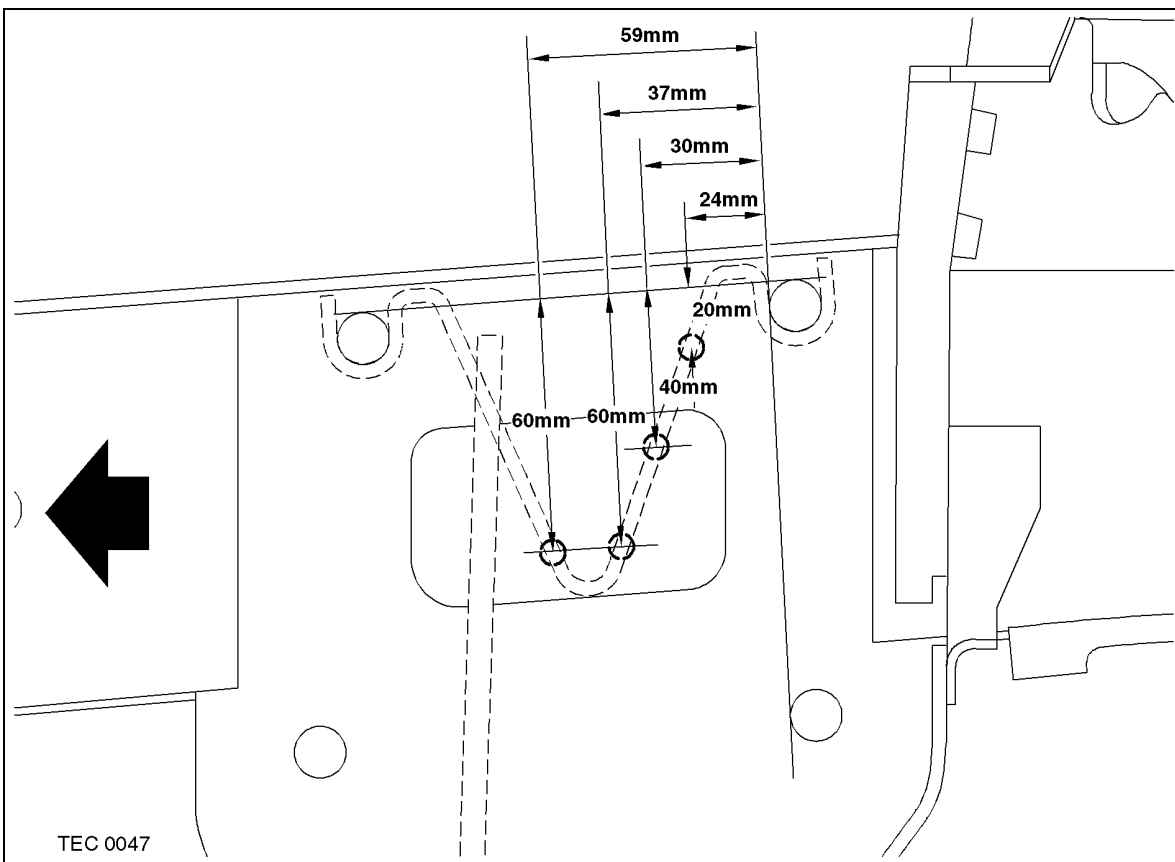
TEC 0047

Left hand drive vehicle (Arrow points towards front of vehicle)
