TECHNICAL BULLETIN

MODEL/DERIVATIVE:
Defender

Bulletin N°: 0081
CDS. ref: L8708
Issue: 1
Date: 31.10.01

PROBLEM:
FRESH AIR VENT - WATER / DUST INGRESS AND DIFFICULT TO CLOSE

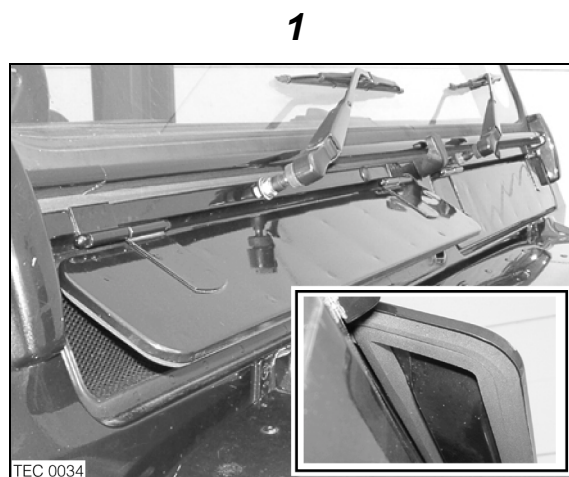
- Water or dust ingress into vehicle through fresh air vent seal.
- Fresh air vent difficult to close.

CAUSE:
Failure of fresh air vent seal material.

ACTION:
Where a complaint of the above is confirmed, follow the procedure below to replace the fresh air vent seal with the improved seal detailed in *PARTS INFORMATION*.

1. Fully open fresh air vent.
2. Remove 2 bolts securing the fresh air vent control arm to fresh air vent.
3. Remove nuts securing hinge pins, release pins and remove the fresh air vent.
4. Carefully remove and discard seal, clean surface to remove any remaining adhesive.
5. Remove backing from the new fresh air vent seal and carefully align it to the edges of the fresh air vent, (inset in illustration 1), press seal firmly home.
6. Align fresh air vent to fresh air vent control arm and finger tighten bolts.
7. Lubricate hinge pins, align fresh air vent to hinges, fit pins and tighten nuts to 6 Nm.
8. If paint finish on nuts is damaged repair as required.
9. Tighten fresh air vent control arm bolts to 10 Nm.
10. Close fresh air vent.
