# TECHNICAL BULLETIN

*MODEL/DERIVATIVE:*  
Discovery Series II  
Defender

*Bulletin N°:* 0029  
*CDS. ref:* L8625bu  
*Issue:* 1  
*Date:* 19.12.01

*PROBLEM:*  
**UNNECESSARY REPLACEMENT OF CYLINDER HEAD**

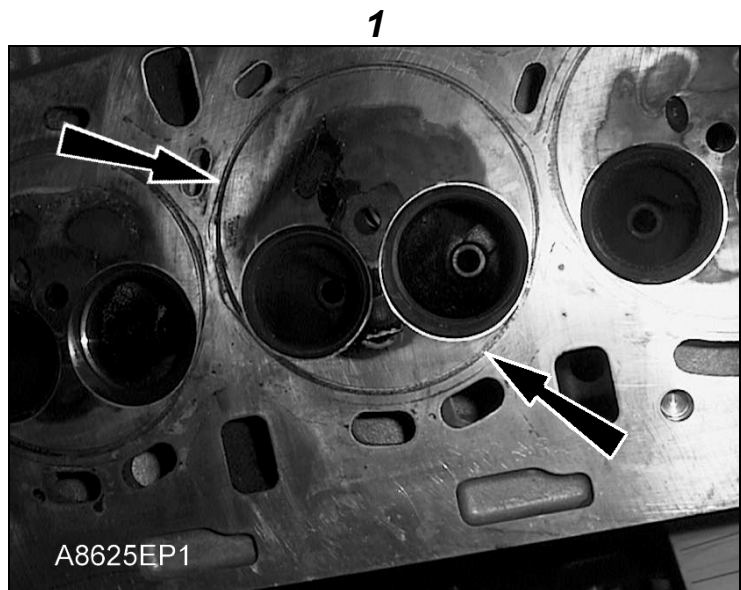
*ACTION:*  
Illustration 1 shows a typical cylinder head mating face.

The fretting marks surrounding the combustion areas, (arrowed in illustration) have been the subject of enquiries from the Dealer network.

Investigation by Land Rover Engineering has confirmed that these marks are completely normal and have no detrimental effect whatsoever on the operation of the engine.

Cylinder heads must therefore **NOT** be changed for this reason alone.

Prior to refitting, the fire face of the head should have any raised material in the area of the gasket sealing bead removed using a carborundum stone. Only a fine stone in good condition should be used. The face should then be thoroughly cleaned before the head is refitted with a new gasket. Providing that all other aspects of cylinder head condition are satisfactory, (flatness for example), the cylinder head can be refitted.
