TECHNICAL BULLETIN

Freelander

Bulletin No: **0017** CDS. ref: **L8626bu**

KNOCKING NOISE FROM STEERING WHEEL AREA

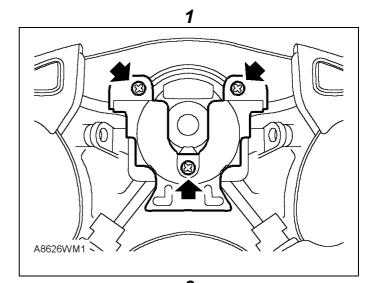
Vibration mass damper, mounted in the steering wheel, contacts fixing on underside of airbag.

3mm 3mm

- 1. Remove drivers airbag, Workshop Manual repair number 76.74.01 refers.
- 2. Referring to illustration 1, remove 3 screws securing damper to steering wheel and remove damper.
- 3. Referring to illustration 2, mark out the damper as shown, measuring 3mm either side of the right angle section.
- 4. Remove the shaded portion of material to produce a 45° chamfer.

When removing material from the damper, take care to prevent distortion of the damper mounting plate and damage to the rubber damper supports.
