# TECHNICAL BULLETIN

**MODEL/DERIVATIVE:**  
Discovery Series II

**Bulletin N°:** 0030  
**CDS. ref:** L8632bu  
**Issue:** 1  
**Date:** 24.01.01

**PROBLEM:**  
UNABLE TO REMOVE FUEL FILLER CAP

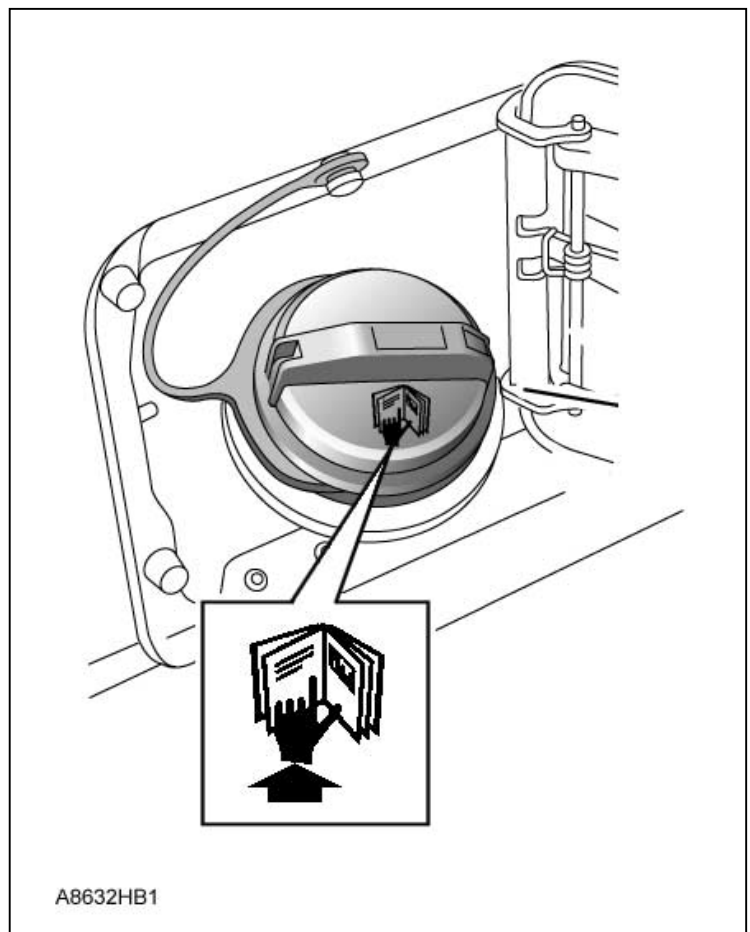
The customer complains that the fuel filler cap spins freely and cannot be removed from the fuel filler neck.

**CAUSE:**  
Failure of the ratchet mechanism within the filler cap.

1. Rotate the filler cap so that the orientation of the handbook symbol is as shown in the illustration, aligned with the lower edge of the filler neck.
2. Identify point at the base of the hand symbol, (arrowed in illustration) and mark with punch.
3. Carefully hand drill a 3mm hole at this point, **TO A MAXIMUM DEPTH OF 10mm.**

*The hole must be no deeper than 10mm to avoid damage to the filler neck.*

4. Insert and tighten a self tapping screw. Use a pointed drive screw 4 to 5mm diameter X 10mm maximum length.
5. The filler cap can now be removed in the usual way.
