# TECHNICAL BULLETIN

Range Rover  
Discovery Series II  
Defender

Bulletin N<sup>o</sup>: 0018  
CDS. ref: L8635bu  
Issue: 1  
Date: 09.05.01

### OIL LEAK FROM GEARBOX - FRONT COVER

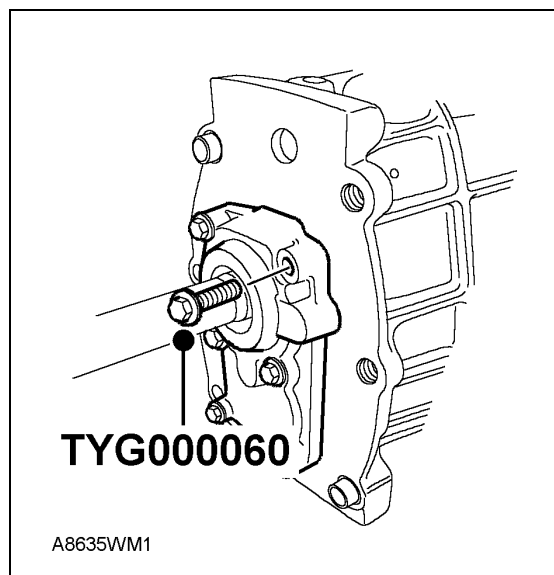
A customer complaint of oil leakage is confirmed to originate from the front of the gearbox.

An oil leak path can develop along the threads of the front cover securing bolts.

The new bolts, part number TYG000060, are now available from Land Rover Parts and should be used during all R380 gearbox repairs where the front cover is disturbed.

- Ensure that all mating faces are cleaned and degreased.
- If necessary, replace the input shaft oil seal.
- Apply sealant STC4404 (Marston 607), originally introduced on Technical Bulletin

0013.
- Tighten bolts to a torque of 25Nm in a diagonal sequence.
