# TECHNICAL BULLETIN

**MODEL/DERIVATIVE:**  
Freelander

**Bulletin N°:** 0002  
**CDS. ref:** L8654bu  
**Issue:** 2  
**Date:** 06.02.02

**PROBLEM:**  
**INCORRECT IDENTIFICATION OF GEARBOX FLUID LEVEL PLUG**

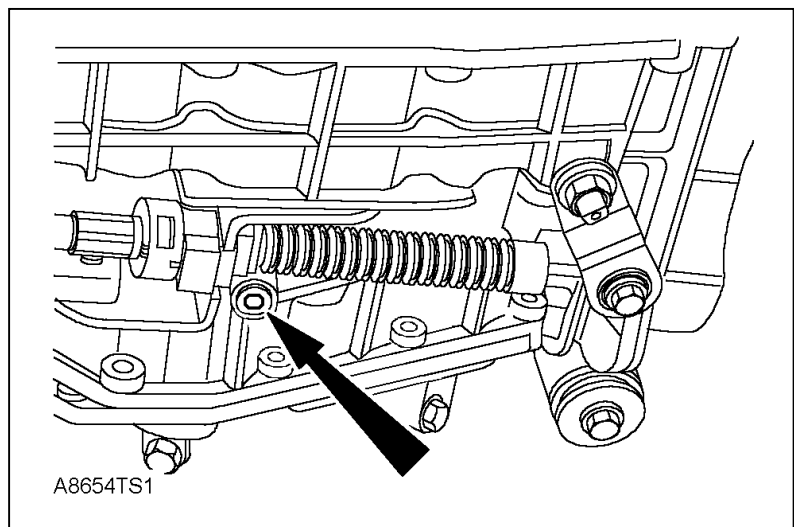
**CAUSE:**  
When checking the fluid level on the JATCO automatic transmission incorrect bolts are being removed / loosened, causing serious damage & malfunction.

- Removal of the reduction gear brake band bolt can cause total loss of drive or a substantial reduction in the performance of the transmission.
- Removal of the parking pawl rod plate retaining bolt (located next to the XYZ switch) will result in gear selection problems / gear lever movement restrictions.

**ACTION:**  
The level plug (arrowed) is fitted vertically into the underside of the gearbox casing, alongside the selector cable bracket and can be identified by its 5mm Allen socket head.

The level plug closes the lower end of an internal level tube, therefore only excess fluid will be expelled when the plug is removed.

Under **NO CIRCUMSTANCES** must these items be removed or loosened - doing so will invalidate any warranty claim made. In normal service, only the fluid level plug and fluid filler plug should be removed.

**Observe due care when draining gearbox fluid as the fluid can be very hot.**

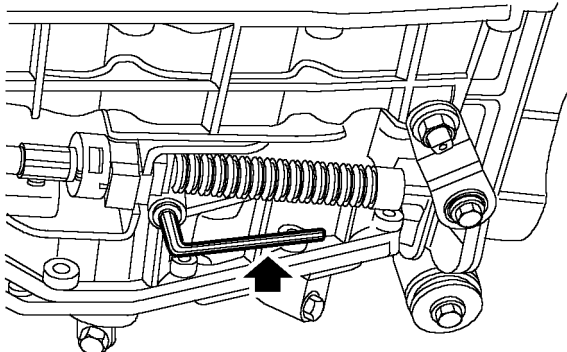
M44 1644

**CAUTION:** There are a number of similar fixings/plugs on the underside of the gearbox. It is imperative that the correct plug is removed prior to checking the level. Removing the wrong fixing/plug could result in internal damage to the gearbox.

7. With the engine still running, remove level plug using a 5 mm Allen socket and allow any excess fluid to drain off.
