TECHNICAL BULLETIN

MODEL/DERIVATIVE:
Range Rover

Bulletin N°: 0032
CDS. ref: L8655bu
Issue: 1
Date: 23.05.01

PROBLEM:
SIDE REPEATER LAMP ADRIFT FROM FRONT WING

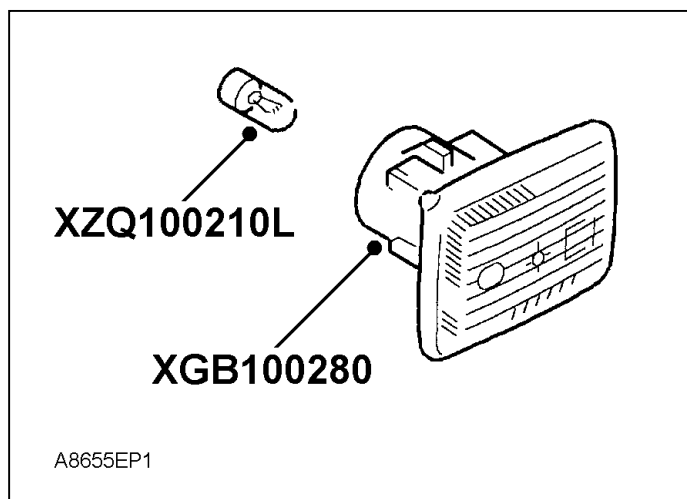
CAUSE:
Failure of the repeater lamp retaining clip.

ACTION:
On customer complaint of poor side repeater lamp retention on a vehicle prior to the above VIN, replace the faulty unit with improved part XGB100280.

NOTE: XGB100280 has a clear lens.
If the lamp to be replaced has an amber lens, replace both lamps and fit new bulbs XZQ100210L.
