# TECHNICAL BULLETIN

**MODEL/DERIVATIVE:**  
Discovery Series II

**Bulletin N°:** 0089  
**CDS. ref:** L8656bu  
**Issue:** 1  
**Date:** 16.01.02

**LOAD SPACE ROLLER BLIND - PRESS STUD BROKEN**

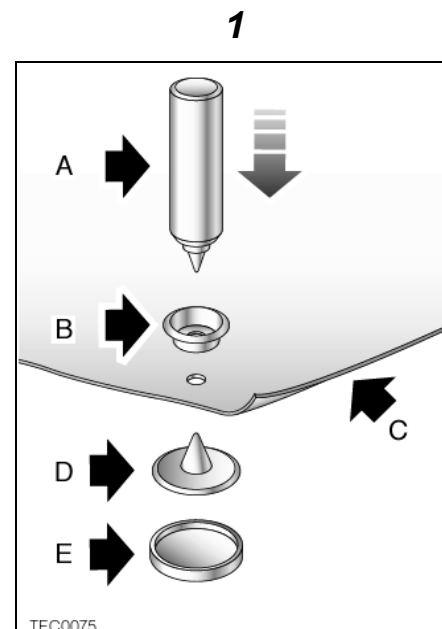
The press stud that secures the load space roller blind to the rear seat may break under excessive force.

Press stud alignment and durability.

Where a complaint of the above is confirmed, replace the load space roller blind press stud with a new press stud now available from Land Rover Parts.

1. Release and remove the load space roller blind.
2. Position the load space roller blind on a clean flat bench and remove the broken press stud.
3. From the underside of the load space roller blind, locate the stemmed button ('D' in illustration 1), through the roller blind fabric ('C' in illustration 1). Position the die ('E' in illustration 1), to the stemmed button.
4. From the top of the load space roller blind, locate the female socket ('B' in illustration 1), over the stemmed button.
5. From the top of the load space roller blind, position the punch ('A' in illustration 1) to the top of the stemmed button and strike with a hammer.  
**NOTE: If the press stud rotates in the fabric repeat step 5 until the press stud is secure.**
6. Remove the die.
7. Fit the load space roller blind and secure in retainers.
8. Secure load space roller blind to the rear seat using the press stud.
