# TECHNICAL BULLETIN

Freelander

Bulletin N<sup>o</sup>: 0076  
CDS. ref: L8664bu  
Issue: 1  
Date: 17.10.01

**WATER INGRESS INTO VEHICLE**

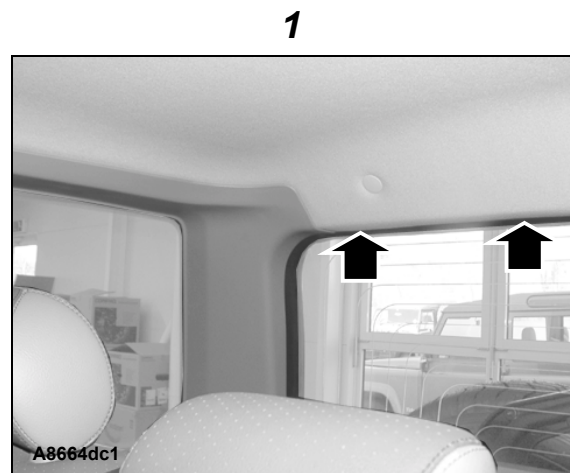
Wet or stained rear edge of headlining

**Water ingress point rear edge of headlining**

1. Remove taildoor glass side finishers (arrowed in illustration 2), refer to Workshop Manual, Doors, repair number 76.43.81 for removal and refit procedure.
2. Carefully release taildoor upper finisher from fixings.
3. Remove five screws securing taildoor upper finisher bracket to body.
4. Ensure that the lokuts are pushed fully home to the panel.
5. If lokuts are damaged or fail to locate correctly, replace with new lokuts, part number DYH100980. Defective lokuts can be cut out with a sharp blade taking care not to damage the panel.

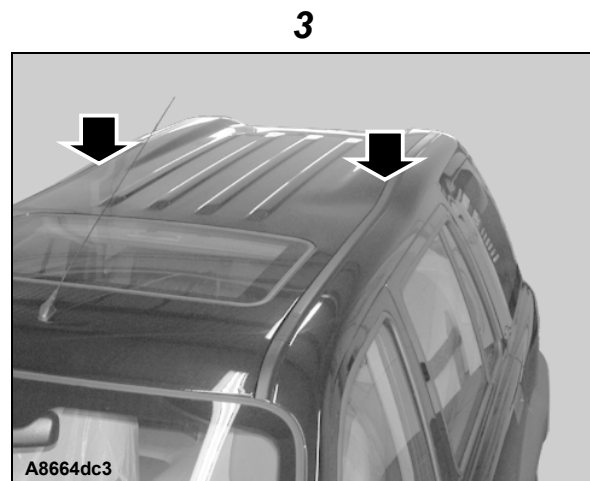
Wet or stained headlining

1. Remove roof moulding, refer to Workshop Manual, Exterior Fittings, repair number 76.43.68.
2. Inspect full length of roof channel seams for pin holes.
3. Fill any holes with polyurethane sealant.
4. Apply water to the suspected entry area to ensure leak has been cured.
5. Fit roof moulding.

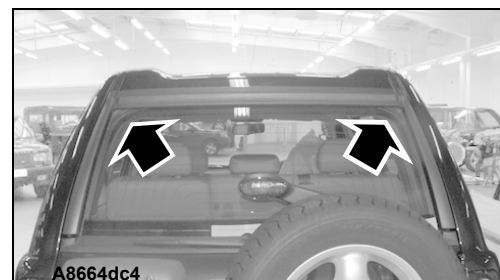
**4**

**Water ingress from taildoor glass to seal**

To ensure that the taildoor glass slides into position underneath the seal (arrowed in illustration 4) to prevent water ingress.

1. If door glass does not move into the correct position when closing, refer to Workshop Manual repair number 76.31.20 for glass adjustment procedure.

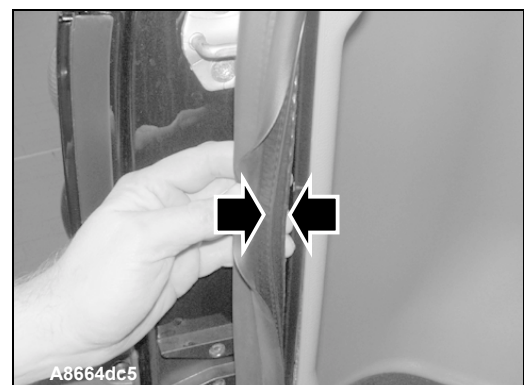
**5**

**Water ingress via taildoor seal**

1. Pull gently on the lower part of the seal to see if it releases from the flange.
2. If the aperture seal is not held securely, release the seal. Using a pair of pliers, close the metal carrier on the seal (arrowed in illustration 5). This will increase the clamping force on the flange.
3. Fit the seal to the flange, ensuring that it is now secure.

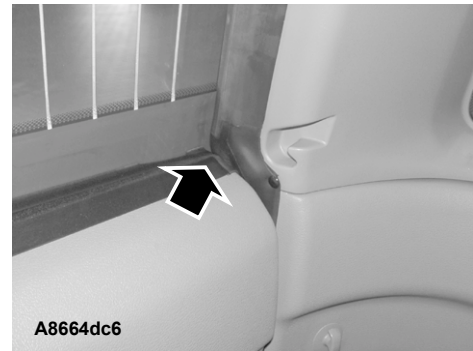
6

Water ingress via taildoor seal

1. Look through the left and right hand rear quarter glass, for a visible gap between the taildoor aperture seal and the taildoor (arrowed in illustration 6).
2. If a gap can be seen, check that the taildoor is correctly set and aligned to the body.
3. Open the taildoor and inspect the aperture seal at waist line height to see if the rubber insert is at its highest position within its retaining rubber membrane.
4. If the rubber insert is not at its highest position, cut a piece of plastic tube to the correct length and glue into the membrane (arrowed in illustration 7), to increase the seal contact to the door.

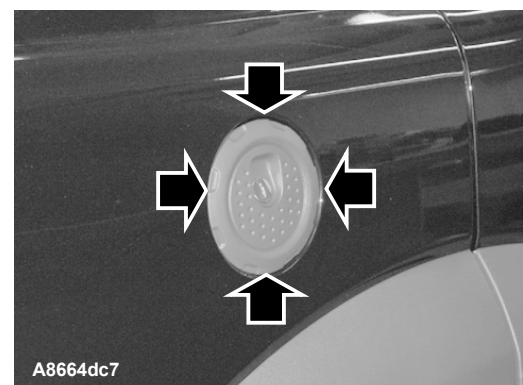
8

Interior quarter panels wet

1. Remove the lower rear quarter trim casing, refer to Workshop Manual, repair number 76.13.12 for removal and refit procedure.
2. Apply water to the fuel filler area (arrowed in illustration 8), and check if water is entering the box section around the ventilation flaps, (The water will run down the wheel arch seam and into the box section).
3. If water is present remove fuel filler cap, seal the fuel filler aperture seam using Clear Polyurethane sealant.
4. Refit trim casing and fuel filler cap.

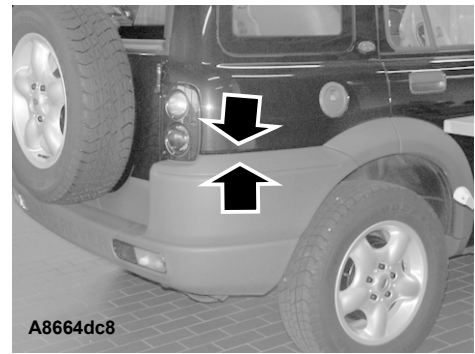
9

Interior quarter panels wet

1. Remove the lower rear quarter trim casing, refer to Workshop Manual, repair number 76.13.12 for removal and refit procedure.
2. Apply a continuous flow of water between the rear bumper and side panel (arrowed in illustration 9).
3. Check to see if water is present at the box section below body vents.
4. If water is present remove bumper valance, refer to Workshop Manual, Exterior Fittings, repair number 76.22.74 for removal and refit procedure.
5. Apply Polyurethane sealant around edge of body vent (arrowed in illustration 10) sealing it to the body.
6. Clean area where shedder will be applied. Remove backing paper from shedder, place shedder over vent with adhesive strip along shaded area (illustration 10a). Ensure the shedder covers the body vent.
7. Before fitting bumper and trim casing, seal rear wheel arch seam, procedure 9.
8. Fit bumper and trim casing.

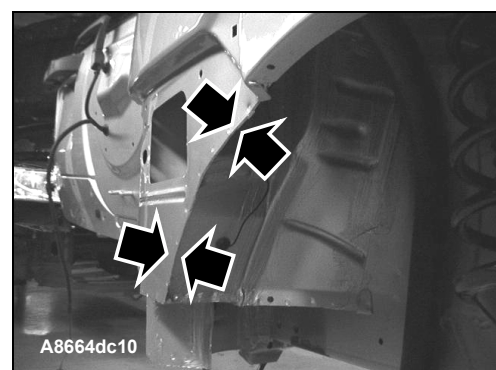
11

Interior quarter panels wet

3. Remove rear wheel arch liner, refer to Workshop Manual, Exterior fittings, repair number 76.10.49 for removal and refit procedure.
4. Apply a continuous flow of water to the seam (arrowed in illustration 11).
5. Check to see if water is present in the box section.
6. If water is present in box section, seal rear wheel arch seam (arrowed in illustration 11), using polyurethane sealant.
7. Before fitting wheel arch liner, bumper and trim casing, seal body vent, procedure 8.
8. Fit wheel arch liner, bumper valance and trim casing

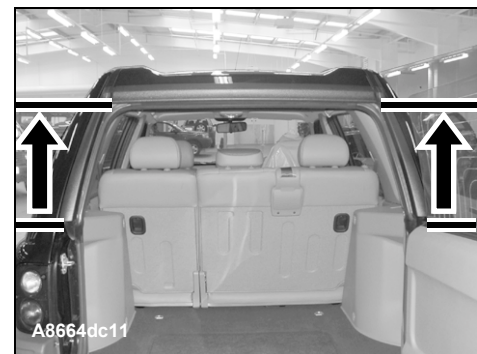
12

Wet 'E' post trims

1. Remove 6 Torx screws securing luggage compartment carpet retainer.
2. Remove carpet retainer.
3. Open taildoor, apply a continuous flow of water to the taildoor aperture seal sealant, slowly working up each side from waist level, (arrowed in illustration 12).

4. Whilst applying water, check if water is present where the carpet retainer is normally fitted.
5. If a leak is detected in the sealant, fill the gap with polyurethane sealant.

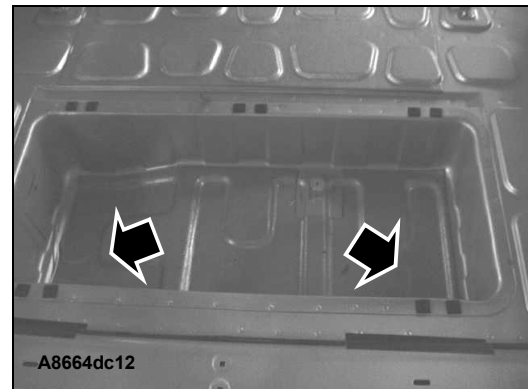
**14**

**Water in stowage box**

1. Remove the luggage compartment carpet, refer to Workshop Manual, Interior Trim Components, repair number 76.49.04 for removal and refit procedure.
2. Inspect 2 fused bungs to confirm that they are located securely in the floor, (arrowed in illustration 14).
3. Seal around the grommets with polyurethane sealant.
4. Fit carpet.

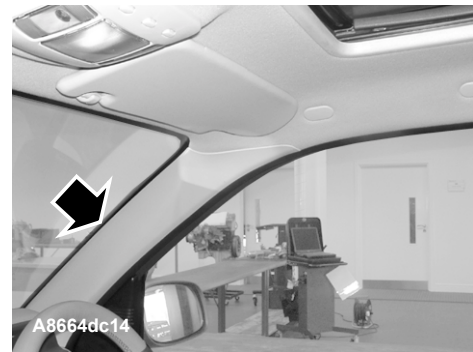
**15**

**Wetness around sealant at top or sides of windscreen**

1. Remove 'A' post upper trim finishers (arrowed in illustration 15), refer to Workshop Manual, Interior Trim Components, repair number 76.13.26 for removal and refit procedure.
2. Remove sun visor, refer to Workshop Manual, Interior Trim Components, repair number 76.10.47 for removal and refit procedure.
3. Remove lens from interior lamp.
4. Remove 2 fixings securing front interior lamp to body and release from headlining. Disconnect multi plug and remove lamp.
5. Remove screw covers and screws from grab handles and remove handles.
6. Remove grab handle blanking plugs.
7. If necessary support headlining.
8. Apply water to the top and side edges of windscreen, whilst from inside the vehicle, check for water entering through the sealant.
9. Fill any holes between aperture and windscreen (arrowed in illustration 16), with polyurethane sealant.
10. Refit components that have been removed.

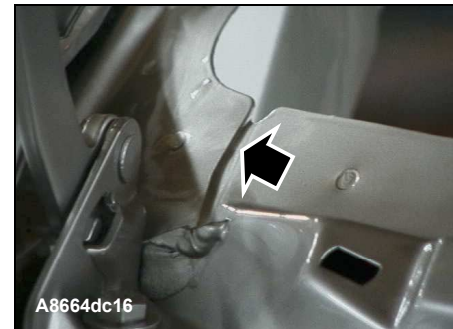
**17**

**Wetness at base of ‘A’ posts**

1. Apply sealant to areas (arrowed in illustrations 17 and 18).

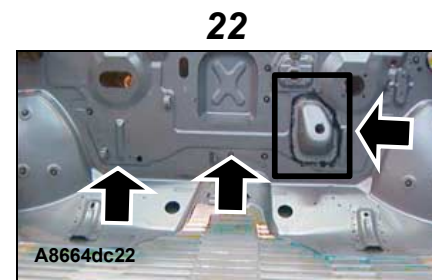
Wetness under fascia in footwell

Areas of spot weld blow holes

7. Lift bonnet and apply water to bulkhead in the engine compartment whilst checking for water in the vehicle footwell. The water will soak through the NVH cover on the bulkhead and run into the footwell.
8. If water is present in the footwell, cut the NVH cover to reveal the water ingress point and seal the spot weld blow hole with polyurethane sealant.
9. Apply tape where the NVH has been cut.
10. Carry out procedure 8 - Heater pipe grommet, to ensure grommet is located correctly.
11. Refit removed components.

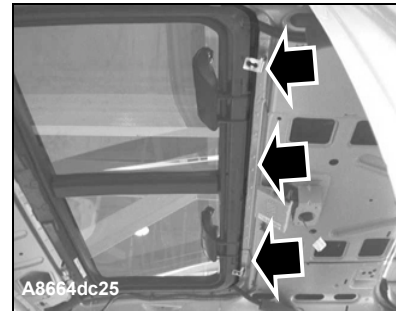
25

Wetness from sunroof

1. Apply water to sunroof whilst looking for water ingress around the sunroof aperture (arrowed in illustration 25).
2. Remove headlining, refer to Workshop Manual, Interior Trim Components, repair number 76.64.15 for removal and refit procedure.
3. Seal water ingress point with polyurethane sealant.
4. Refit headlining.

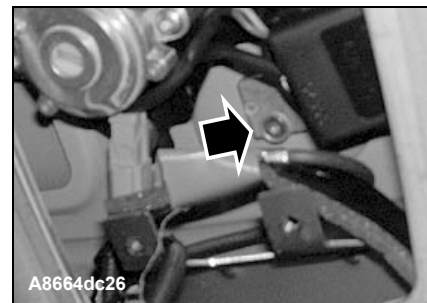
26

Wetness under aerial on headlining

1. Remove lens from front interior lamp.
2. Remove 2 screws securing front interior lamp to body.
3. Release interior lamp from headlining, disconnect multiplug and remove lamp.
4. Apply water to aerial base whilst looking for water ingress around the aerial fixing (arrowed in illustration 26).
5. If water is present around the interior aerial fixing point, tighten nut securing aerial to 6 Nm.
6. Re-apply water, if leak is still present, release, but do not remove nut securing aerial.
7. Raise aerial base clear from roof panel, clean contact faces of aerial rubber seal and roof panel.
8. Apply polyurethane sealant between aerial rubber seal and roof panel (arrowed in illustration 27).
9. Tighten nut securing aerial to 6 Nm, remove excess sealant.
10. Refit front interior lamp.
