# TECHNICAL BULLETIN

**MODEL/DERIVATIVE:**  
Defender

**Bulletin N°:** 0021  
**CDS. ref:** L8678bu  
**Issue:** 1  
**Date:** 12.12.01

**PROBLEM:**  
FRONT RADIUS ARM NOISE / CREAK

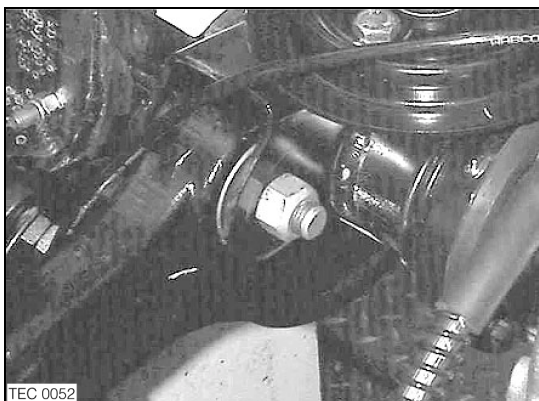
1

**CAUSE:**  
Insufficient torque / clamp load on the fixings securing the radius arms to the axle case bracket.

**Illustration shows radius arm bracket without welded washers**

Where a complaint of the above is confirmed, inspect the front radius arm to axle case brackets. If the brackets do not incorporate a welded washer and the nuts and bolts are to the old specification, (see illustration 1) and ('A' in illustration 2), the nuts and bolts must be replaced with the new specification flange headed nuts and bolts, ('B' in illustration 2).

1. Raise vehicle on lift.
2. Remove nut from radius arm bolt to axle case bracket and remove bolt.
3. Fit new radius arm bolt and nut to axle case bracket, torque to 210 Nm.  
Caution: Ensure torque does not exceed 230 Nm.
4. Repeat steps 2 – 3 for the remaining fixings. Replace fixings individually.

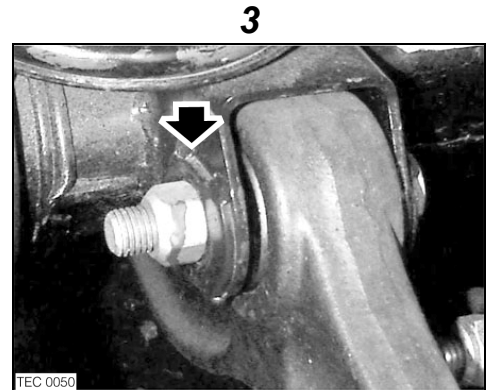
**Illustration shows radius arm bracket with welded washers**

**Caution: Vehicles with the welded washer on radius arm axle case bracket, (arrowed in illustration 3), torque radius arm fixing bolt and nut to 176 Nm, ensure torque does not exceed 185 Nm.**
