TECHNICAL BULLETIN

MODEL/DERIVATIVE:
All Discovery Series II

Bulletin N°: 0019
CDS. ref: L8702bu
Issue: 1
Date: 17.10.01

PROBLEM:
POTENTIAL TYRE / RADIUS ARM FOUL FOLLOWING A STEERING BOX CHANGE

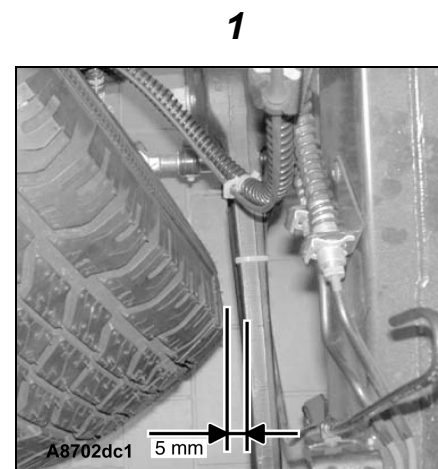
- After a Power Assisted Steering (PAS) box replacement, a foul condition may be experienced between the tyre and radius arm.
- Following a PAS box replacement, the clearance between the front tyres and suspension radius arms must be checked on extremes, of both full left hand and right hand steering lock. Failure to do this may cause the customer to complain of a noise from the front of the vehicle on full steering lock.

1. Turn the steering wheel to left then right full lock, and have an assistant check for clearance each side between the tyre on the inner steered wheel and the radius arm (illustration 1).
2. If the measured clearance on either lock is less than 5mm, then a new lockstop must be fitted.

ACTION:
When a PAS steering box has been replaced, follow the procedure below to check there is sufficient clearance between the tyre and radius arm. If there is not sufficient clearance, replace the lockstop with the new extended length lockstop part number TTE000010 (colour coded blue).
