TECHNICAL BULLETIN

MODEL/DERIVATIVE:
Defender 90 / 110 Hard top and Station Wagon

Bulletin N°: 0078
CDS. ref: L8712bu
Issue: 1
Date: 24.10.01

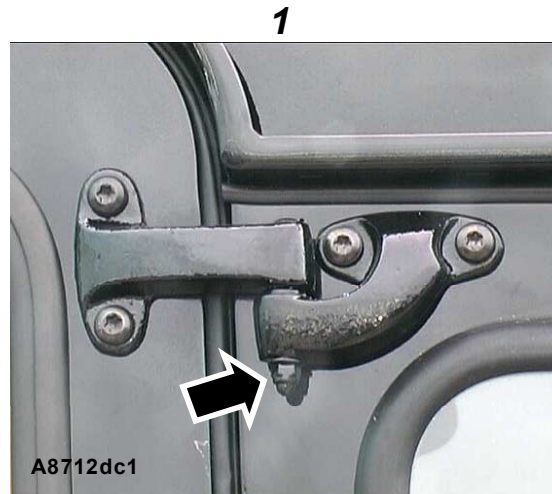
PROBLEM:
EXCESSIVE TAIL DOOR HINGE LOAD AND NOISE DURING OPERATION
The customer complains that the tail door is difficult to open and of a creaking noise when opening the tail door.

CAUSE:
Incorrect torque applied to the tail door hinge.

ACTION:
Where a customer complaint of the above is confirmed, reset the hinges using the following procedure:

1. Carefully remove tail door hinge pin retaining nut, (arrowed in illustration 1), and remove spring.
Note: Take care, when removing nut so the paint finish is not damaged.
2. Clean hinge pin thread.
3. Apply a small amount of thread lock to the thread.
4. Fit spring and nut to hinge pin.
5. Tighten nut until contact is made with the hinge body, back the nut off approximately half a turn.
6. Repeat steps 1 - 4 for remaining hinges.
7. If paint finish on nut is damaged repair as required.
8. Lubricate and check operation of tail door hinges, refer to Workshop Manual, Maintenance, Door Locks and Hinges.
