# TECHNICAL BULLETIN

**MODEL/DERIVATIVE:**  
Freelander

**Bulletin N°:** 0083  
**CDS. ref:** L8715bu  
**Issue:** 1  
**Date:** 21.11.01

**PROBLEM:**  
REAR CONSOLE LID CATCH BROKEN

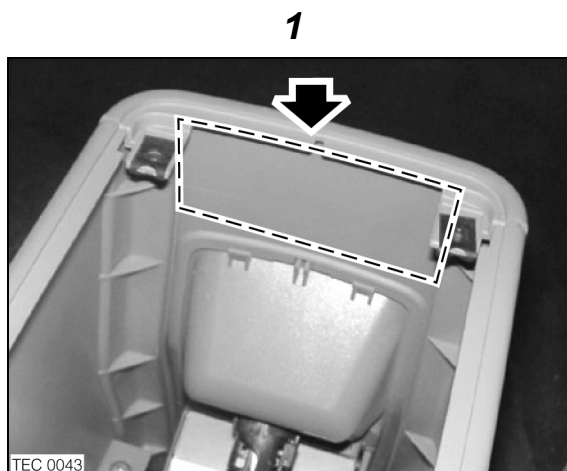
**CAUSE:**  
The rear console lid detaches from the cubby box and the catch becomes misaligned to the console. When the lid is closed in this condition the catch breaks.

Where a complaint of the above is confirmed, replace the rear console lid with a new lid, which is now available from Land Rover parts.

1. Remove the oddments tray liner from the console lid.
2. Raise the console lid and remove 4 screws securing the console lid and cubby box to the console.
3. Carefully remove the console lid and cubby box from the console.
4. Release the console lid from the cubby box.
5. Clean console rear finisher, within the dotted line area, (arrowed in illustration 1).
6. Cut rubber pad AZF100040, to fit within the dotted line, (arrowed in illustration 1), and fix to the top edge of the console finisher. The rubber pad stops the hinge from detaching.
7. Fit and secure a new console lid FJB100370LPR to the cubby box.
8. Carefully fit console lid and cubby box to the console and secure with 4 screws.
9. Fit the oddments tray liner to the console lid.
10. Check operation of the console lid.
