# TECHNICAL BULLETIN

**MODEL/DERIVATIVE:**  
Discovery Series II

**Bulletin N°:** 0077  
**CDS. ref:** L8716bu  
**Issue:** 1  
**Date:** 17.10.01

**PROBLEM:**  
TAIL LAMP CRACKED

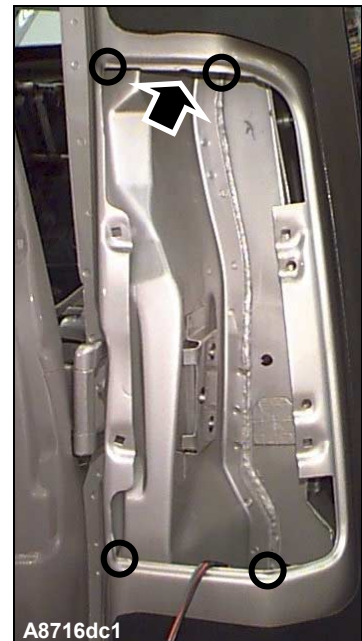
A8716dc1

**CAUSE:**  
Due to Body in White specification, stresses can be placed on the tail lamp causing it to crack.

1. Remove tail lamp, refer to Workshop Manual, Lighting, repair number 86.40.70.
2. To remove the stress points on the tail lamp, file 4 small semi circles into the lamp aperture, in areas shown circled on the illustration. Offer the tail lamp to the aperture, noting where on the tail lamp the possible stress points will be. The size of the semi circles should be similar to that arrowed in the illustration.

To ensure that the semi circles will not be seen when the new lamp is fitted, offer the new tail lamp to the aperture before proceeding.

3. Repair paint finish as required. Where bare metal has been exposed, etch prime prior to painting.
4. Fit new tail lamp, refer to Workshop Manual, Lighting, repair number 86.40.70.
