TECHNICAL BULLETIN

MODEL/DERIVATIVE:
Defender

Bulletin N°: 0082
CDS. ref: L8721bu
Issue: 1
Date: 14.11.01

NOISE / CREAK FROM THE FRONT SEAT

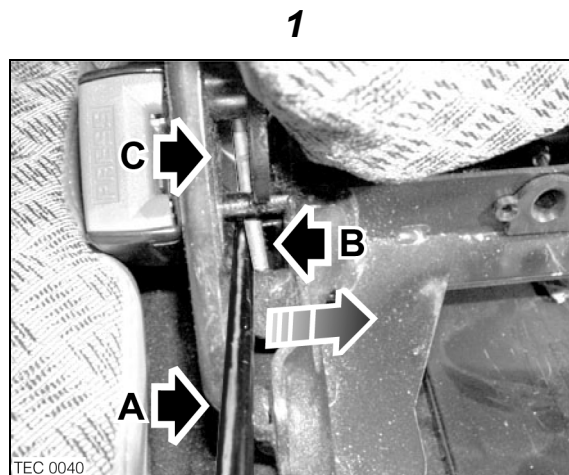
When a front seat is moved, a noise / creak can be heard in the cushion to squab area.

The tension bar on the front seat squab, rubs on the cushion side plate.

1. Remove seat cushion to allow access to the seat squab tension bar.
2. Using a suitable screwdriver, (arrowed 'A' in illustration 1), bend the tension bar (arrowed 'B' in illustration 1) away from the cushion side plate to create a minimum clearance of 2 mm (arrowed 'C' in illustration 1). If needed, bend the side plate slightly to create a clearance.
3. Fold seat forward and back ensuring tension bar is clear of the side plate.
4. Refit seat cushion.
5. Repeat for opposite seat if necessary.
