TECHNICAL BULLETIN

**Discovery Series II
Range Rover
Defender**

Bulletin N°: **0028**
CDS. ref: **L8726bu**
Issue: **1**
Date: **12.12.01**

OIL LEAKAGE FROM REAR OF ENGINE

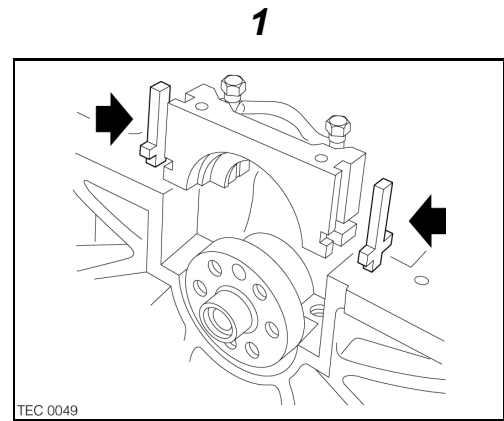
- Leak from the rear main bearing cap side seals.
- Leak from the rear main bearing cap sealant area.
- Leak from the crankshaft rear oil seal.

8. Fit new side seals detailed in *PARTS INFORMATION* to the main bearing cap, (arrowed in illustration 1).
9. Apply a 3mm wide bead of sealant detailed in *PARTS INFORMATION* to the main bearing cap rear mating faces on the cylinder block, (arrowed in illustration 2).
