# TECHNICAL BULLETIN

**MODEL/DERIVATIVE:**  
Defender

**Bulletin N°:** 0093  
**CDS. ref:** L8738bu  
**Issue:** 1  
**Date:** 06.02.02

**PROBLEM:**  
**CORROSION AROUND THE REAR BODY CORNER CAPPING**  
Corrosion may be evident around the left or right hand rear body corner capping, see inset in illustration 1.

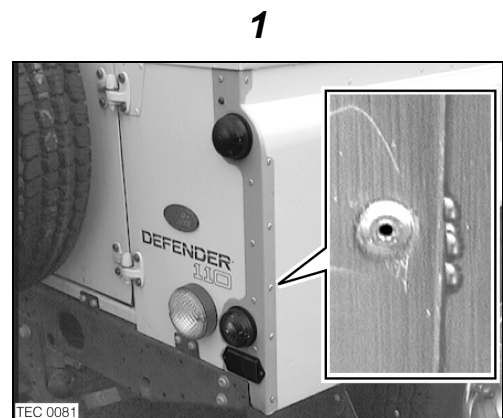
**CAUSE:**  
Due to material specification and design of the connecting panel work.

Right hand shown for illustration purposes only

**ACTION:**  
Where a complaint of the above is confirmed, follow the rectification procedure below to replace the rear body corner capping.

1. Remove the rear direction indicator, tail lamp, reflector and the reverse or fog lamp.
2. **RIGHT HAND:** remove the Land Rover logo and decals.
3. **LEFT HAND:** remove the rear number plate lamp, refer to Workshop Manual, part number LRL0097 (3<sup>rd</sup> edition), Electrical, Rear Number Plate Lamp, repair number 86.40.86. Remove the number plate.
4. Drill out rivets securing the corner capping.
5. Carefully remove the corner capping.
6. Remove any corrosion from the body panels.
7. Etch prime any bare metal.
8. Apply primer to the prepared area and the mating faces of the new corner capping.
9. Carefully position the new corner capping and secure with rivets.
10. Local paint the corner capping and the body panels.
11. Fade out into existing body colour.
12. Fit removed components.
