TECHNICAL BULLETIN

MODEL/DERIVATIVE:
Defender

Bulletin N°: **0092**
CDS. ref: **L8751bu**
Issue: **1**
Date: **30.01.02**

DIFFICULT TO RELEASE KEY FROM DOOR LOCKING BARREL

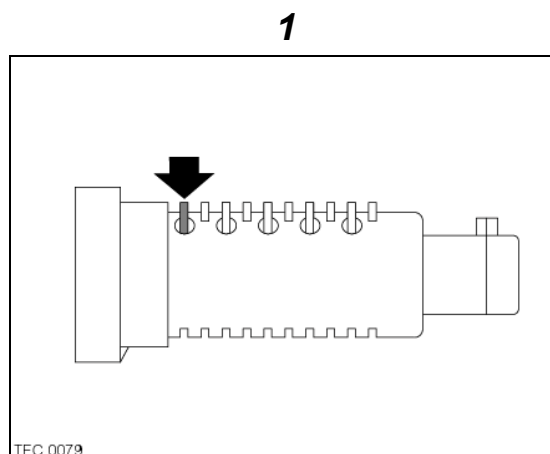
When fitting a new door locking barrel the key may not release from the barrel.

The stiffening ring in the locking sleeve could prevent the first lock tumbler from lifting when the key is withdrawn, preventing removal of the key.

Before fitting a new door locking barrel to vehicles in VIN range 2A 622429 to 2A 627483, the door lock barrel must be modified by following the procedure below.

1. Remove the first tumbler and spring (Arrowed in illustration 1), from the door locking barrel.
