TECHNICAL BULLETIN

MODEL/DERIVATIVE:
**Discovery Series II
Defender**

Bulletin N°: **0008**
CDS. ref: **L8755bu**
Issue: **1**
Date: **30.01.02**

PROBLEM:
ORANGE RESIDUE ON THE WATER PUMP BRACKET

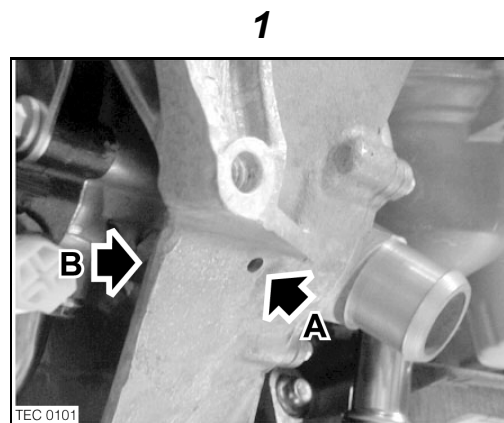
CAUSE:
The orange residue is due to evaporation of the coolant, which originates from the water pump and forms the orange residue. The residue accumulates around the drain hole in the water/power steering pump housing and also inside the housing, refer to illustration 1, arrows A and B respectively.

Area where residue is found

ACTION:
Water pumps must not be replaced because of the orange residue unless coolant can physically be seen running/dripping from the water pump.
The residue is normal and has no detrimental effect on the operation of the water pump.
