TECHNICAL BULLETIN

MODEL/DERIVATIVE:
Defender

Bulletin N°: 0066
CDS. ref: L8615bu
Issue: 1
Date: 25.04.01

PROBLEM:
SHRINKAGE / POOR FIT OF CANVAS HOOD

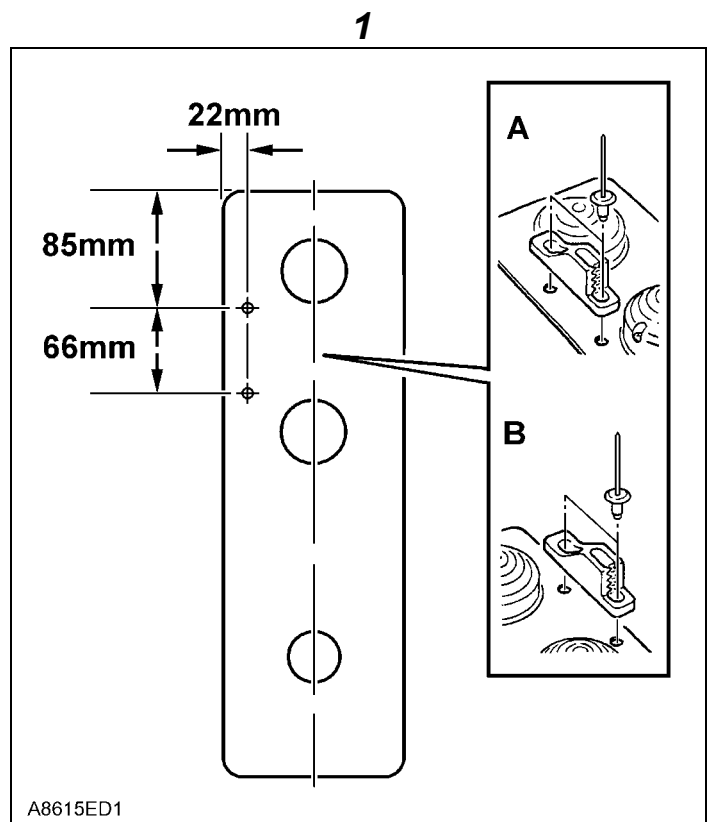
The customer complains of deterioration of the hood appearance.

CAUSE:
Degradation of the hood material.

1. Remove the existing hood.
2. Remove both rear lamp assemblies.
3. Referring to illustration 1, drill two holes in each rear lamp mounting plate as described below;
 - RH assembly, (illustrated). From the top face of the mounting plate, measure 85mm vertically down the LH edge of the plate and mark.
 - From this point, measure down a further 66mm and mark.

- At each of the marked positions, mark a point 22mm from the LH edge of the plate.
- Drill a 4.9mm hole at each position.
- Repeat for LH assembly, positioning holes on the RH side of the plate to produce a mirror image of the RH assembly.

4. Attach one cleat DJL000010 to each mounting plate with orientation as shown in inset 'A', (RH) and inset 'B' (LH), using two rivets RRC4583 for each cleat.
5. Refit rear lamp assemblies.
6. Fit replacement hood. Refer to *PARTS INFORMATION* for derivative / part number detail.
