TECHNICAL BULLETIN

MODEL/DERIVATIVE:
Range Rover

Bulletin N°: 0059
CDS. ref: L8621bu
Issue: 1
Date: 27.09.2000

PROBLEM:
FRONT SEAT LUMBAR SUPPORT WILL NOT INFLATE / DEFLATE

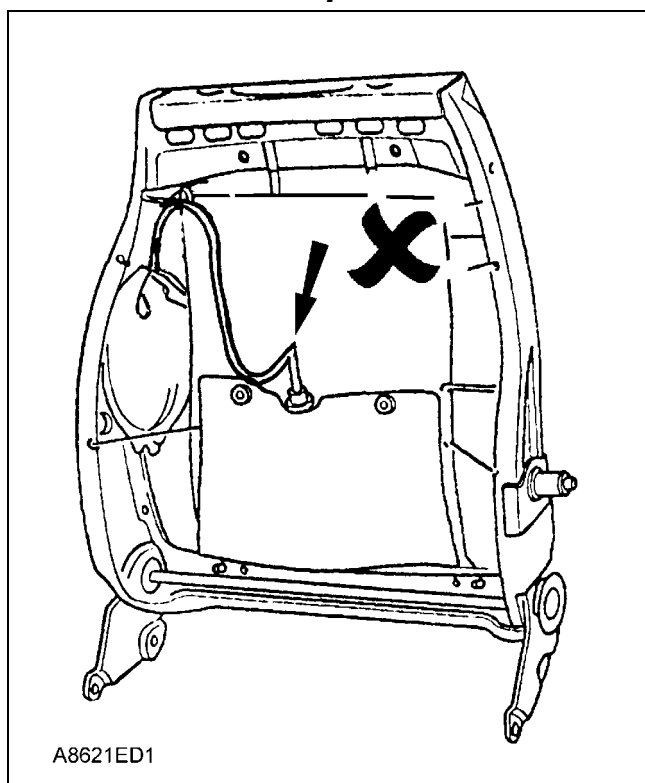
CAUSE:
Kinks in the lumbar support air tube due to the tube being incorrectly routed.

4. Raise squab cover to enable a hand to be inserted to locate the lumbar support air tube.
5. Check the full length of the tube for kinks, (illustration 1 refers).
6. Reposition the tube to eliminate kinks and give a smooth path, (illustration 2 refers).
7. Confirm that lumbar support operation is now satisfactory.
8. Refit shock cords, remove strings and refit squab cover to frame.
