TECHNICAL BULLETIN

Range Rover
Discovery Series II
Defender

Bulletin N°: 0029
CDS. ref: L8623bu
Issue: 1
Date: 15.11.2000

ENGINE WILL NOT START / STARTS INTERMITTENTLY

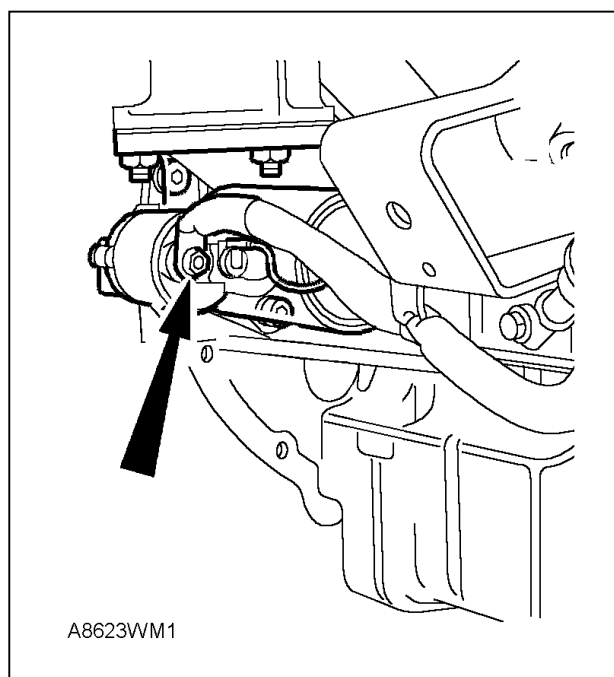
The engine will not start due to the starter motor becoming inoperative.

Poor electrical connection between the main battery lead and the starter motor solenoid.

At the final VINs above, the torque setting for the battery lead connection to the starter motor was increased from 10 Nm to 18 Nm.

1. Disconnect earth lead from battery.
2. Raise vehicle, (Discovery and Defender only).
3. Locate battery lead to starter motor solenoid connection, (arrowed in illustration).
4. Tighten solenoid nut to the new torque of 18 Nm.
5. Lower vehicle, (if necessary) and reconnect battery earth lead.
