TECHNICAL BULLETIN

MODEL/DERIVATIVE: Freelander
 Bulletin N°:
 0017

HILL DESCENT CONTROL (HDC) INOPERATIVE

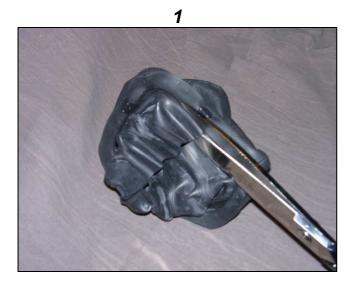
Where a leather gaiter is fitted, examine the interior of the gaiter for a complete rubber gaiter. Illustration 1 shows a complete rubber gaiter which has been pulled out of the leather gaiter so that it can be cut away.

Cut the rubber gaiter as shown in illustration 1, leaving only the rubber base as shown in illustration 2, for securing to the console.
