# TECHNICAL BULLETIN

**MODEL/DERIVATIVE:**  
**Discovery Series II**

**Bulletin N°:** 0030  
**CDS. ref:** L8629bu  
**Issue:** 1  
**Date:** 24.01.01

**FRONT SCREEN WIPER ARM FAILS TO OPERATE**

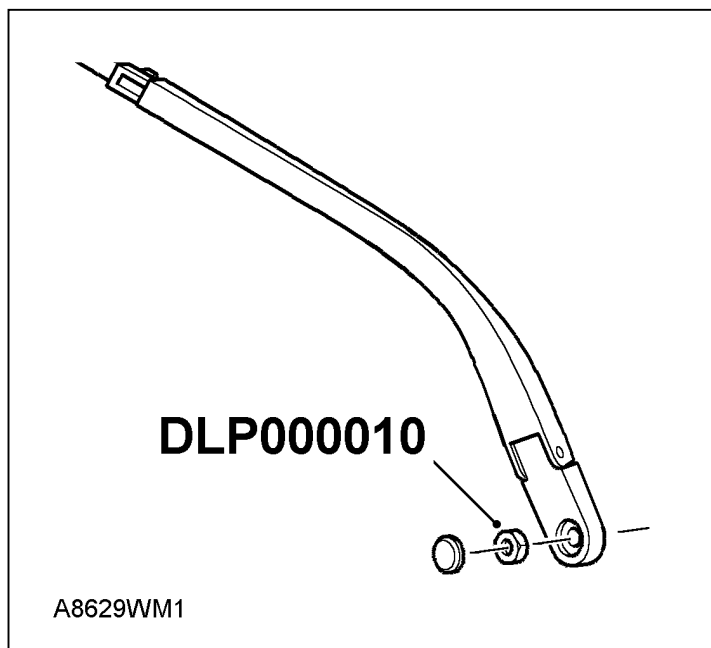
**One or both of the wiper arms may stop working or fail to move when switched on.**

**Torque relaxation on one or both wiper arm securing nuts, resulting in loss of drive to the wiper arm.**

**Where a customer complaint of wipers not moving is confirmed to be the result of the wiper arm loose on the linkage, replace both wiper arm securing nuts with new nuts, part number DLP000010.**

**Tighten the new nuts to the revised torque of 20Nm.**
