# TECHNICAL BULLETIN

**MODEL/DERIVATIVE:**  
Discovery Series II

**Bulletin N°:** 0031  
**CDS. ref:** L8638bu  
**Issue:** 1  
**Date:** 21.02.01

**PROBLEM:**  
**ENGINE HARNESS - FITTING PROCEDURE CARE POINTS**

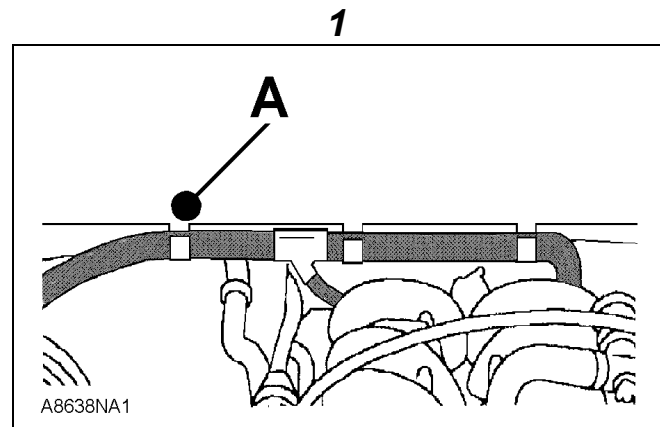
The possibility of damage to an incorrectly installed engine harness due to contact with the rear of the engine. This may result in customer complaints of engine misfire and 'Check Engine' light (MIL) illuminated.

1. Partially remove the bonnet seal from the rear edge of the bonnet aperture to access the three harness clips.
2. Refer to illustration 1. If the clips are located as shown, clip 'A' must be repositioned as shown in illustration 2.
3. Refer to illustration 2. Move clip 'A' from its location in the notch to a new location directly above the brake pipe clip 'B'.
