# TECHNICAL BULLETIN

**MODEL/DERIVATIVE:**  
Discovery Series II

**Bulletin N°:** 0064  
**CDS. ref:** L8639bu  
**Issue:** 1  
**Date:** 11.04.01

**REAR CENTRE SEAT BELT (2<sup>ND</sup> ROW) TRAPPED IN ESCUTCHEON**

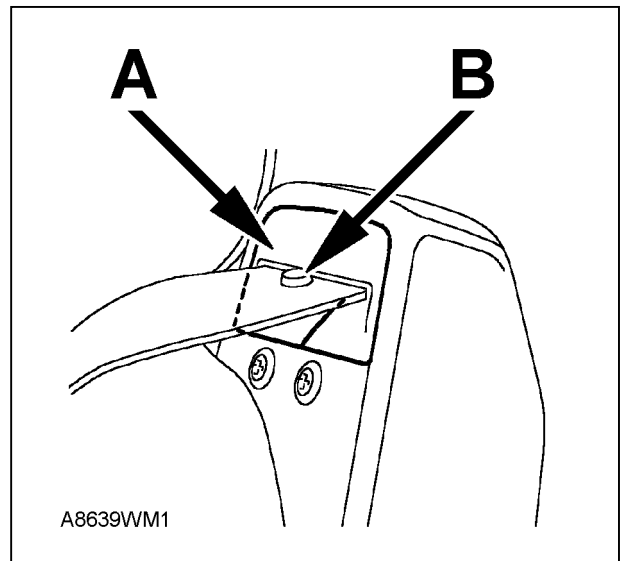
The belt 'stop button' has passed through the aperture in the escutcheon. Should the seat be folded forward to increase stowage space, difficulty may be experienced in returning the seat to the upright position due to the belt being trapped in the escutcheon.

Lack of rigidity in the escutcheon, ('A' in illustration) combined with profile of the seat belt aperture. This permits the belt 'stop button', ('B' in illustration) to pass through the aperture but not to return.

Upon customer complaint of the above, replace the existing escutcheon with the new reinforced escutcheon detailed in *PARTS INFORMATION*.

- Release the escutcheon, upper edge first, from the centre seatbelt cover.
- Remove the escutcheon by passing the belt through the diagonal slot.
- Fit the new escutcheon to the belt.
- Insert the escutcheon, lower edge first, into the centre seatbelt cover.
