TECHNICAL BULLETIN

MODEL/DERIVATIVE:
Freelander

Bulletin N°: 0068
CDS. ref: L8640bu
Issue: 1
Date: 02.05.01

SOFTBACK SEAMS SPLITTING IN 'E' POST AREA.

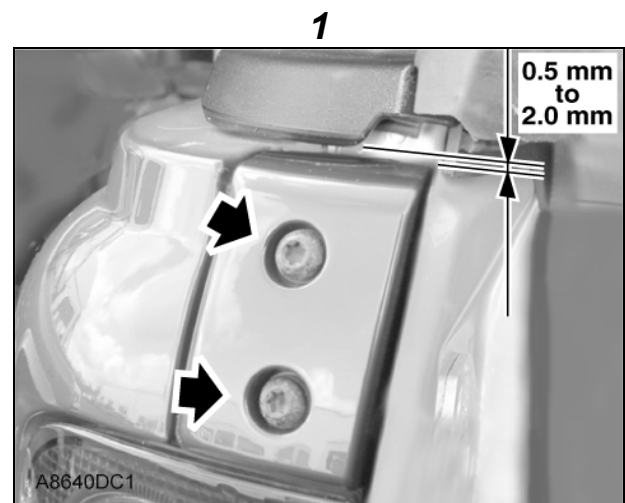
Vehicles without roof bars.

The *minimum* acceptable gap is 0.5mm and the *maximum* acceptable gap is 2.0mm

1. Release the Softback fasteners to reveal the lower body finisher.
2. Loosen the two 'E' post finisher Torx bolts, (arrowed in illustration 1).
3. Push the 'E' post finisher downwards and outboard so that it locates fully onto the body and maintains a minimum gap to the body side. The gap achieved between the 'E' post finisher and the lower body finisher must be between 0.5mm and 2.0mm, (refer to illustration 1).
4. Tighten the two Torx bolts to 4Nm.
