# TECHNICAL BULLETIN

**MODEL/DERIVATIVE:**  
**Discovery Series II**

**Bulletin N°:** 0065  
**CDS. ref:** L8650bu  
**Issue:** 1  
**Date:** 11.04.01

**FRONT SEAT ARM REST LOOSE / ADRIFT**

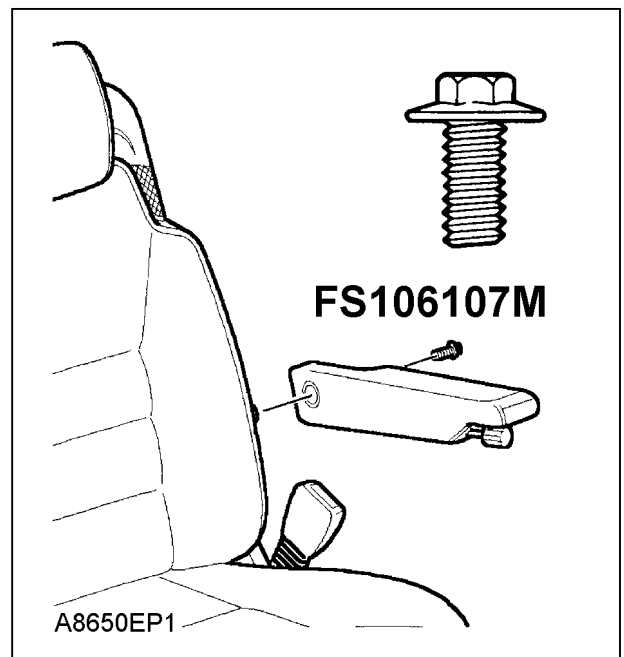
**Incorrect armrest securing screw used intermittently during manufacture.**

**Upon customer complaint of the above, replace the existing armrest securing screws with the correct patch lock screw FS106107M and tighten to a torque of 10Nm.**

**Carry out this action on both seats.**
