TECHNICAL BULLETIN

MODEL/DERIVATIVE:
Discovery Series II

Bulletin N°: **0071**
CDS. ref: **L8662bu**
Issue: **1**
Date: **06.06.01**

PROBLEM:
WELD NUT SHEARS WHEN REMOVING CROSSMEMBER

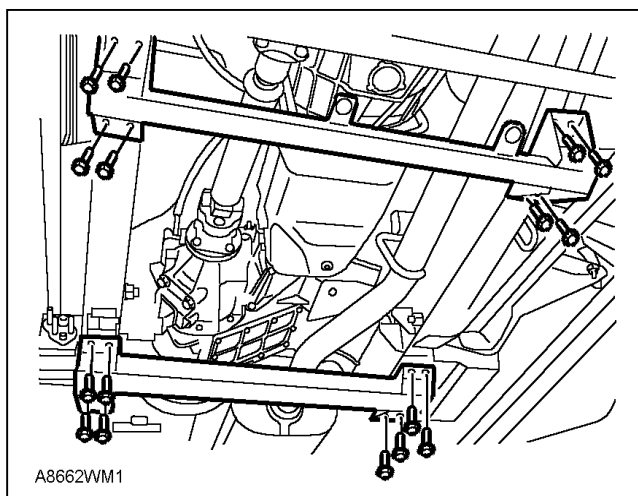
When removing a bolted on chassis cross member for access to other components, weld nuts may break away from the chassis.

CAUSE:
Corrosion of the crossmember bolt in the weld nut.

ACTION:
Where weld nuts have failed, discard the bolt and weld nut and replace with new bolt FT108201L and new nyloc nut NT108041L.

Tighten the new bolts to the originally specified torque of 26Nm.
