TECHNICAL BULLETIN

MODEL/DERIVATIVE:
Freelander

Bulletin N°: 0027
CDS. ref: L8663bu
Issue: 1
Date: 01.08.01

PROBLEM:
NOISE FROM TOP END OF ENGINE - TAPPETS

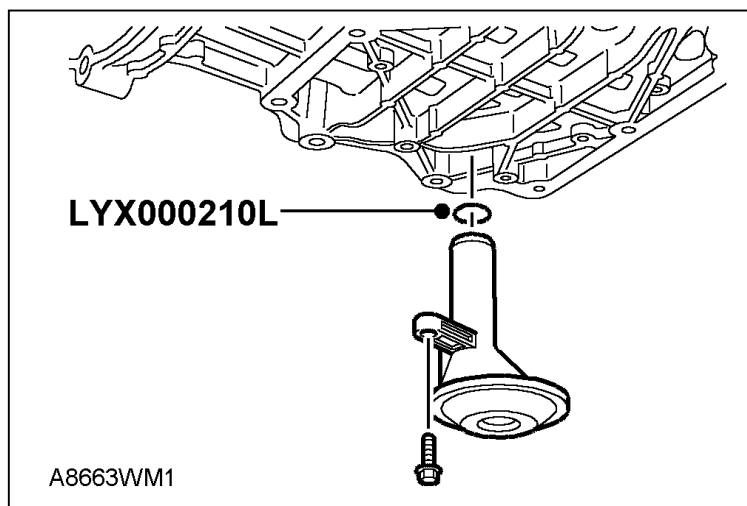
CAUSE:
The 'O' ring seal on the oil suction pipe may have been damaged during engine assembly.
This will allow air into the engine oil and will subsequently lead to noisy tappets.

In the unlikely event that the oil suction pipe is damaged replace with new assembly, part number LSP000040L which includes the new 'O' ring.

If tappet noise persists, replace the 'O' ring seal with new seal, part number LYX000210L.
