TECHNICAL BULLETIN

MODEL/DERIVATIVE:
Defender

Bulletin N°: 0070
CDS. ref: L8674bu
Issue: 2
Date: 21.11.01

FRONT DOOR CANNOT BE UNLOCKED

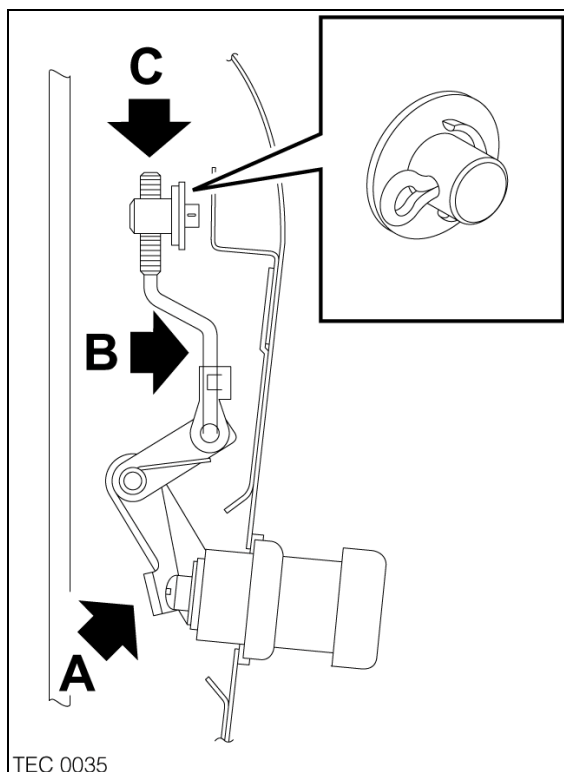
TEC 0035

Door lock interior linkage has jammed.

1. Slide front seat fully rearwards.
2. Release door pull finisher caps, remove 2 screws securing door pull and remove door pull.
3. Remove door locking button bezel.
4. Carefully ease upper corner of trim casing and plastic sheet from door to gain access to the linkage.
5. Locate the release lever, which is operated by the exterior release button, ('A' in illustration). It is likely that the lever will be stuck in the open position, i.e., clear of the release button.

6. Using a flat probe at least 350mm long, return the release lever to the closed position. The door should now open normally.

9. Remove retaining clip securing link rod ('B' in illustration) and adjuster ('C' in illustration) to release lever ('A' in illustration).

10. Remove split pin securing adjuster to latch lever (inset in illustration, remove flat washer and remove adjuster and link rod from latch lever.

11. Fit new adjuster to new link rod and position adjuster midway along the thread.

14. Adjust link so it locates into the release lever, (sliding fit), and secure with retaining clip.
