TECHNICAL BULLETIN

MODEL/DERIVATIVE:
Freelander

Bulletin N°: 0073
CDS. ref: L8681bu
Issue: 1
Date: 04.07.01

PROBLEM:
SEAL - PLENUM COVER TO WINDSCREEN - ADRIFT FROM PLENUM COVER
The customer complains of the untidy appearance of the plenum cover to windscreen seal.

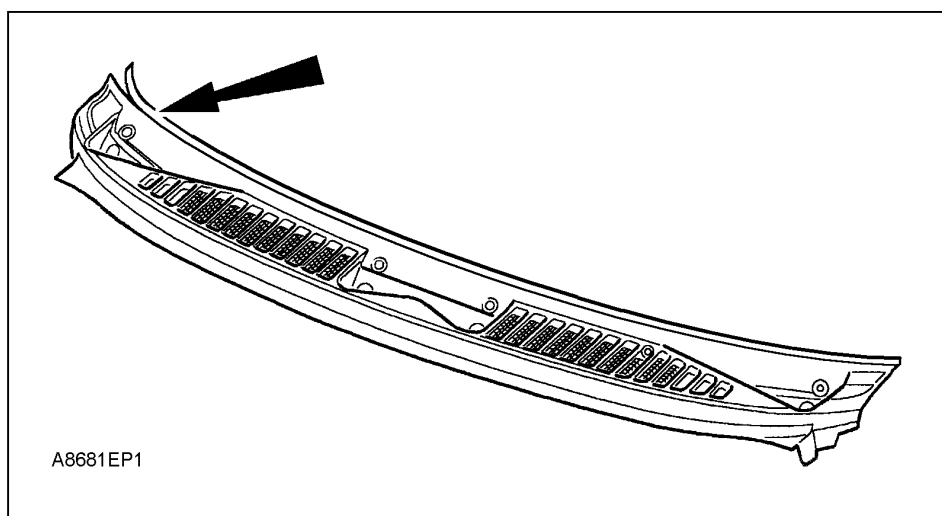
CAUSE:
Poor adhesion of the seal to the plenum cover.

ACTION:
On customer complaint of the above, secure the section of the seal which is displaced to the plenum cover, using the cleaning and adhesive materials detailed in *PARTS INFORMATION*.
Apply the adhesive sparingly to ensure that no excess is squeezed out when the seal is refitted.
