DEALER BULLETIN

SLR/011/00

17 MAY 2000

TECHNICAL BULLETINS

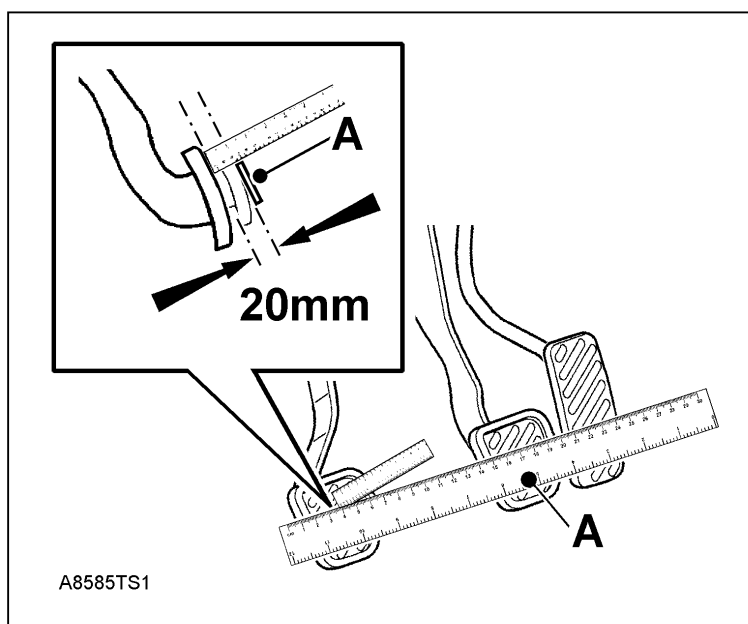
DIFFICULT GEAR ENGAGEMENT - CLUTCH PEDAL

The customer complains of difficulty in engaging gears, particularly when the vehicle is stationary, e.g. at traffic lights.

Insufficient travel in the clutch release mechanism to permit full disengagement of the clutch.

1. Place a rule or similar straight edge on the centre of the brake pedal pad, ('A' in illustration). Ensure that the rule extends across the clutch pedal pad as shown.

2. With a second rule positioned at right angles to the clutch pedal pad, measure the distance from the underside of the first rule to the surface of the clutch pedal pad. The maximum acceptable distance is 20mm, (see inset in illustration).
 3. If the measurement exceeds 20mm, fit new clutch pedal assembly part number SUB100240.
-

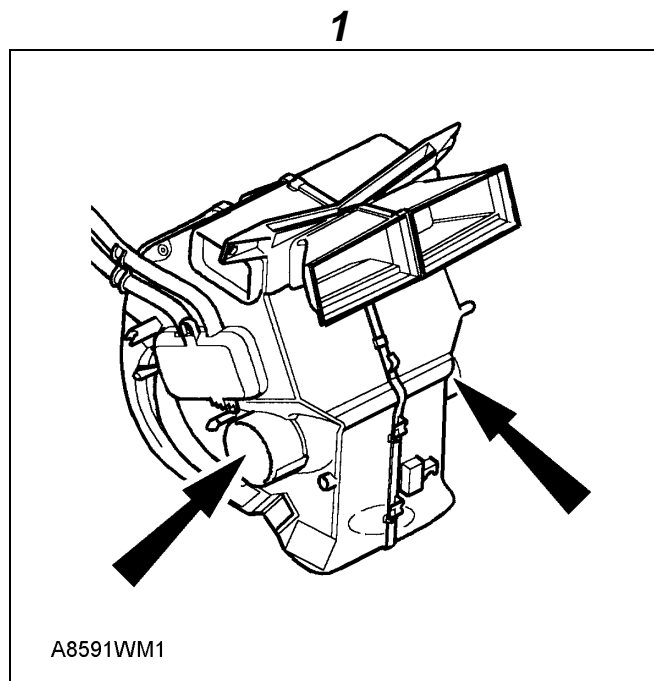
POOR FRONT SCREEN DEMIST PERFORMANCE - DEMIST DUCT

Either or both heater to front screen demist ducts adrift from heater.

1. From the footwell area, examine the point where the left hand and right hand demist ducts attach to each side of the heater, (arrowed in illustration 1). If either or both are adrift from the heater, use the following procedure to ensure security of the duct when refitted.

Ensure that the ducts are not pulled downwards at any time during the repair procedure as this may result in the ducts being released from the seals in the facia rail. Should this happen it will be necessary to remove the facia to achieve correct reinstallation of the ducts.
