**DEALER BULLETIN**

**SLR/031/99**

# TECHNICAL BULLETIN

**ABS WARNING LIGHT ILLUMINATED**

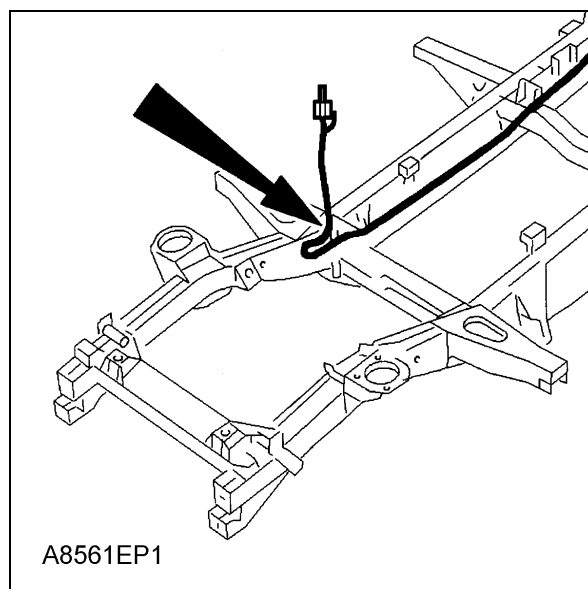
**DAMAGE TO CHASSIS ELECTRICAL HARNESS**

**Chafing damage to the harness, possibly resulting in electrical failures.**

**If incorrectly routed a loop of harness can foul on the front propeller shaft.**

**When replacing a damaged harness or carrying out any repairs in the vicinity of the exposed chassis harness / front propeller shaft, ensure on completion of work, that the harness is correctly routed to give adequate clearance.**

- **With the battery disconnected and the vehicle raised, from beneath the vehicle locate the harness in the area above the front differential and right hand chassis longitudinal.**
- **The harness emerges below the body and enters the right hand chassis longitudinal. Between these two points there is a loop in the harness, (arrowed in illustration), which *MUST* be clear of the propeller shaft.**
- **To ensure correct installation, locate the white marker tape around the harness. This indicates the point at which the harness and grommet should enter the chassis. Feed the harness into the chassis until this is achieved.**

- Confirm that there is now adequate clearance between the harness and the propeller shaft. ***ON NO ACCOUNT*** must the harness be cable tied to any fuel or brake pipes above the chassis.
-
