DEALER BULLETIN

SLR/032/99

01 DECEMBER 1999

TECHNICAL BULLETINS

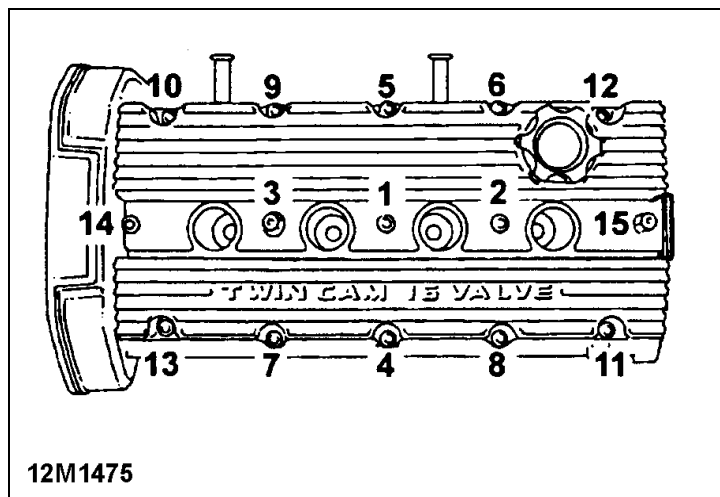
PROBLEM:
OIL LEAK FROM CAMSHAFT COVER TO CAMSHAFT CARRIER JOINT

CAUSE:
Loss of clamp load due to relaxation of the gasket material

NOTE: The new camshaft cover gasket LVP100630L can be identified as having a crimped edge unlike previous gasket LVP100260 which was completely flat.

Where a customer complaint of oil leakage is confirmed to originate from the camshaft cover gasket, replace the gasket with new part LVP100630L.

Ensure that machined faces are not damaged prior to fitting new gasket. Ensure also that camshaft cover to carrier bolts are torqued in the sequence shown in the Workshop Manual and reproduced here.

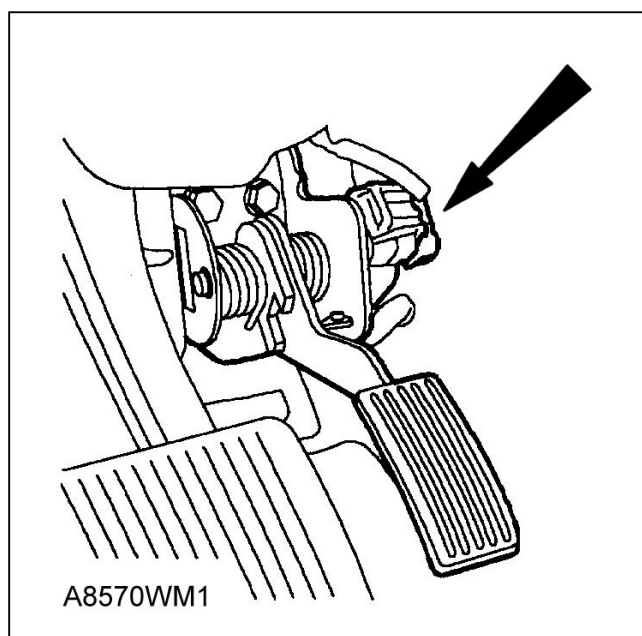
PROBLEM:
'CHECK ENGINE' LIGHT (MIL) ILLUMINATED

The wiring harness connector may not be fully connected and latched to the throttle position (TP) sensor.

The sensor, (arrowed in illustration), is an integral part of the throttle pedal assembly.

Upon customer complaint of the above problem, confirm that the harness connector is fully latched to the TP sensor.

To confirm that the connector is fully latched, simply push home as far as possible. Visually confirm that the latch has engaged and ensure that the connector cannot now be pulled out.

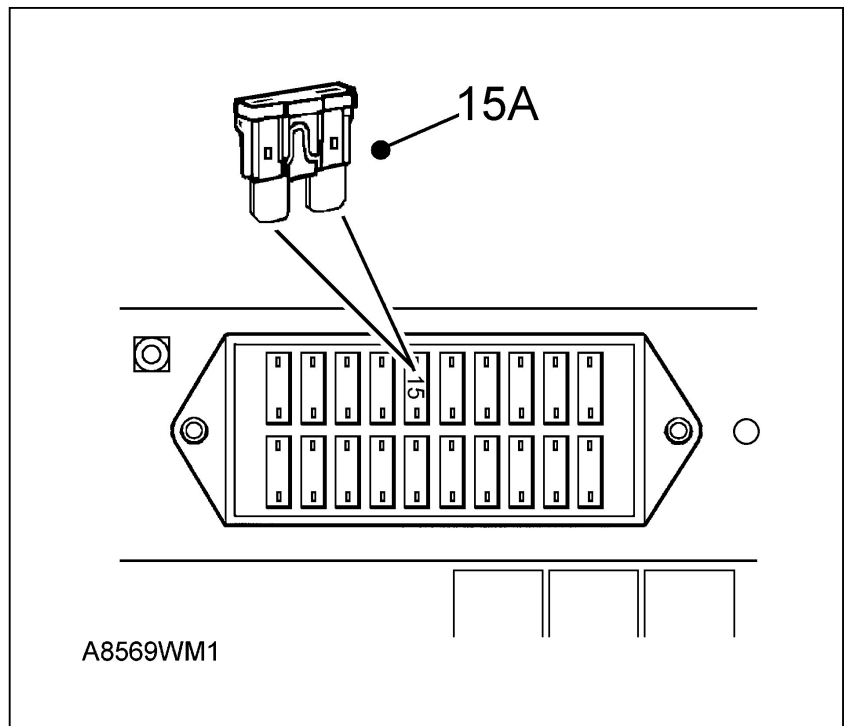
BRAKE LIGHTS INOPERATIVE AND BATTERY LOSES CHARGE WHILE DRIVING

The fuse that protects the stop and reverse lamp circuits has blown, probably as the result of towing a trailer. As this fuse also services the alternator excitation feed the alternator stops charging.

The fuse can blow if the trailer lamps electrical load exceeds 3.5A (2 X 21W bulbs) above normal vehicle load.

The fuse in question is housed in the passenger side fuse box in the location shown in the accompanying illustration.

Where a customer complaint is traced to the above, to prevent repeat failures replace the existing 10A fuse with a 15A fuse.

NOTE: In no circumstance fit a fuse of greater value than 15A as this may cause permanent damage to the vehicle wiring harness.
