SERVICE MGR.	X			
RECEPTION	X			
WORKSHOP	X			
PARTS	X	SUBJECT		30/10/96
		Front Axle Driveshaft - Oil Leak		NRR/54/03/96/EN
MODEL		AFFECTED VEHICLES

New Range Rover		LP	348603 Onwards	
		LH		
		LJ		
		LD

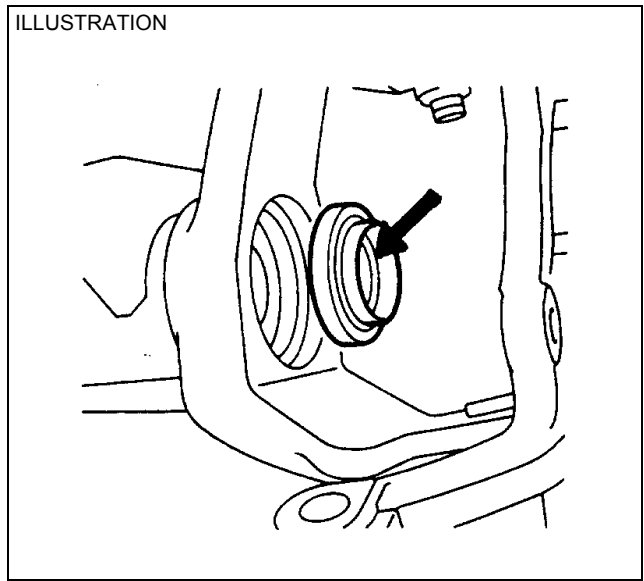
In the event of an oil leak becoming evident from the front driveshaft seal around the yolk area, a new driveshaft seal has been introduced.

Upon customer complaint of an oil leak around the driveshaft area, the new revised seal should be fitted, together with the brake caliper bolts and hub assembly bolts as detailed in the parts section.

FTC 4822 replaces FTC 3452 driveshaft seal

FTC 2996 brake caliper bolts (4 off)
 FC 112127P hub assembly bolts (8 off)

Note: New service tool No LRT-54-012 should be used in conjunction with the driveshaft seal.
