Bulletin
Number 5037

1948-49 "60" AND "75"
LAND-ROVER

CARBURETTOR

1. WEAK MIXTURE FLAT SPOT (LAND-ROVER ONLY)
2. ACCELERATION FLAT SPOT
3. THROTTLE SPINDLE NUTS LOOSE OR MISSING.

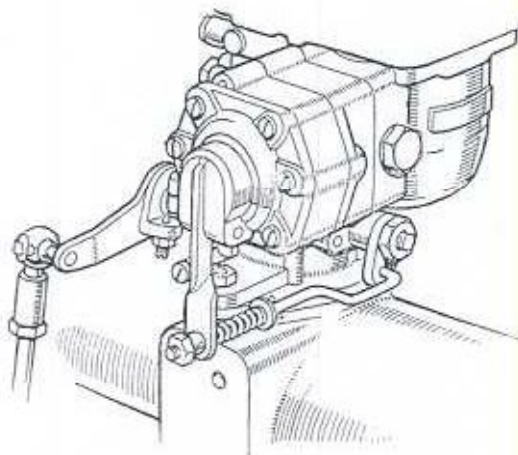
Fig. 1

The carburettor accelerator pump on early Land-Rover engines, illustrated at Fig. 1., is so arranged that the pump operates over most of the throttle range.

On such engines, cases have been reported of a weak mixture flat spot occurring during acceleration; this can be eliminated by converting the pump linkage to the latest pattern (Fig. 2), so that the pump operates only during the first stages of throttle opening.

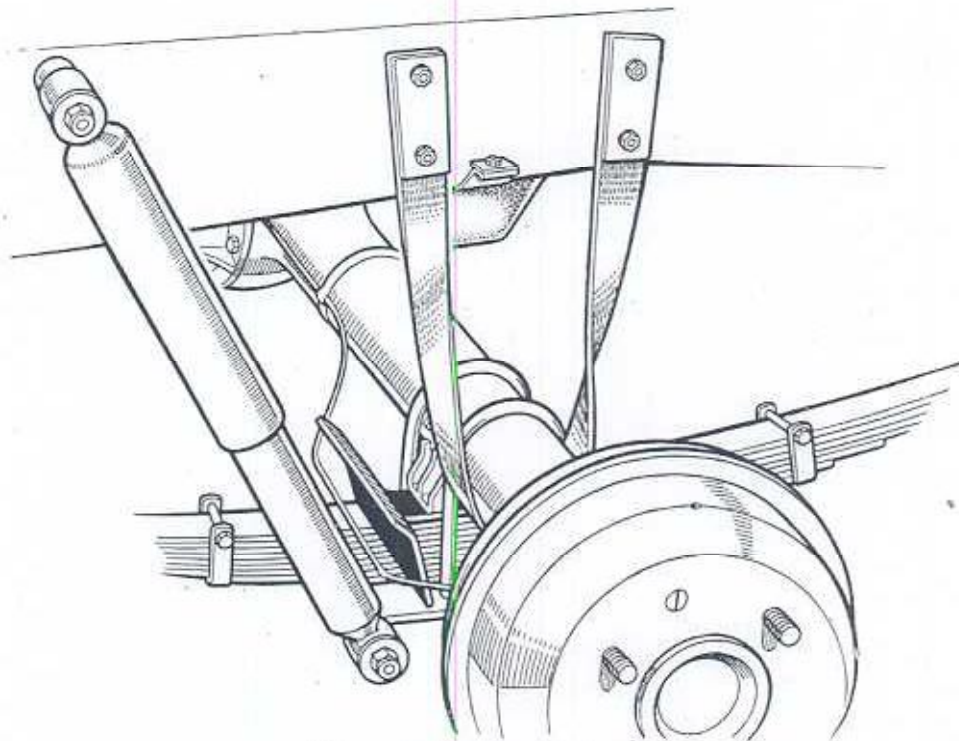
1. Brake failure
- or 2. Fracture of a rear brake pipe at the point where it passes between the shock absorber and rear axle check strap.

Under normal conditions the flexible check strap is slack ; movement of the rear axle may allow the strap to chafe on the brake pipe, ultimately causing a fracture and consequent brake failure.

Fig. 1. Shield for rear brake pipe.

Suitable shields (illustrated in position at Fig. 1) are obtainable free of charge from our Spares Department, the part numbers being L.H. 232089 and R.H. 232088.

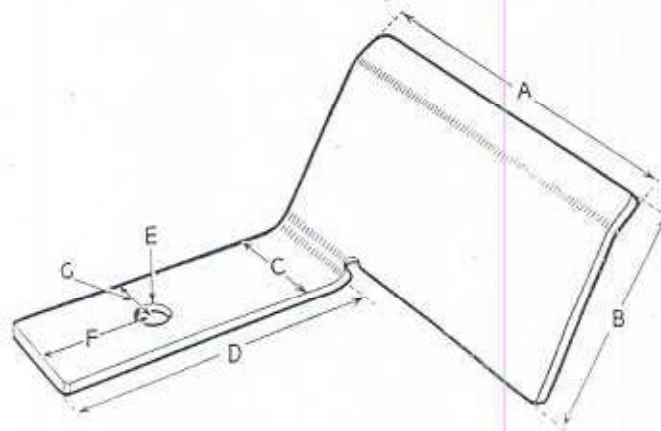
Fig. 2. Details of R.H. brake pipe shield.

Alternatively the shields may be made locally from the dimensions given at Fig. 2.

- A — 5 in. (127 mm.)
- B — 3 in. (76 mm.)
- C — 1 $\frac{7}{8}$ in. (44,5 mm.)
- D — 4 $\frac{1}{2}$ in. (104 mm.)
- E — $\frac{1}{2}$ in. (13 mm.) hole.
- F — 2 in. (51 mm.)
- G — $\frac{3}{8}$ in. (22,25 mm.)

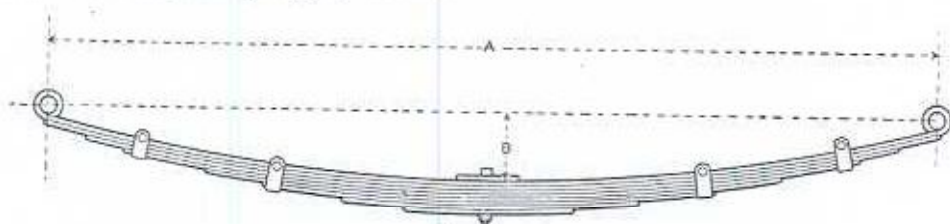
Fig. 1

The **FREE CAMBER** of the spring, when removed from the vehicle, is used as an identification feature. It is indicated by the measurement "B" at Fig. 1, i.e. the distance from the top of the main leaf to the line joining the spring eye centres.

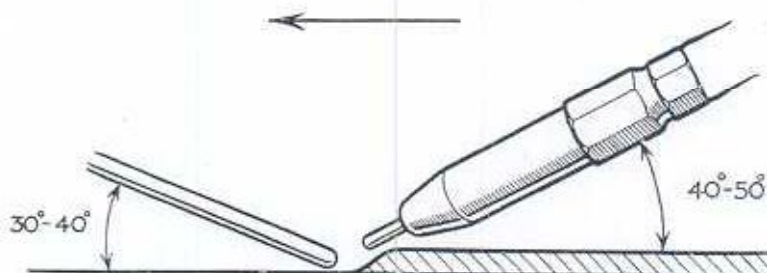
Fig. 1. Leftward method of welding.

The actual weld should be made by using the "Leftward" technique as illustrated at Fig. 1.
