MODELS AFFECTED
1948-50 LAND-ROVER

UNIT AFFECTED
ENGINE

DUST-PROOFING

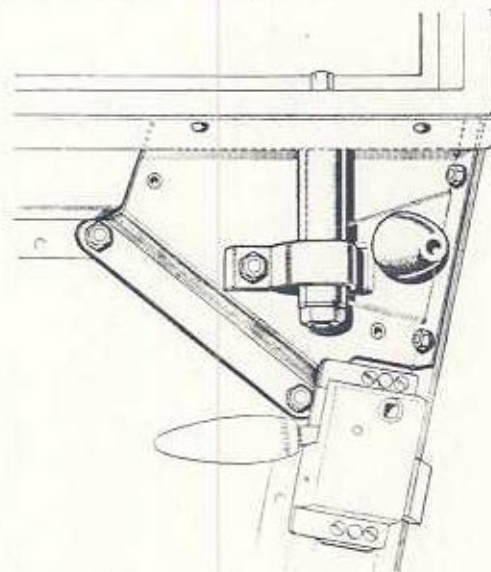
Fig. 1. Door gusset plate.

COMPLAINT. FRACTURE OF DOOR PANEL AT UPPER REAR CORNER

CAUSE Excessive strain on door capping due to vibration at rear edge of side screen.

1. Remove the side screen.
2. Remove the door from the vehicle.
3. Remove the upper buffer from the door.
4. Shear the two rearmost rivets securing the top capping.
5. Secure the free end of the clip to the gusset plate by means of the bolt and plate, spring and plain washers and nut provided.
6. Fit the gusset plate in position as shown at Fig. 1.

7. Drill two $\frac{1}{4}$ in. (6.5 mm.) clearance holes in the door panel and secure the plate by means of the two $\frac{1}{4}$ in. bolts, spring washers and nuts provided.
8. Drill the plate through the rivet holes in the top capping and secure the capping and plate, using two new rivets.

9. Drill two holes in the door shut flange, using the gusset plate as a guide and secure with the two 2 B.A. screws, spring washers and nuts provided; the screw heads should be on the outside of the door.
10. Secure the plate to the door reinforcement by means of the two pop rivets provided.
11. Tighten the clip against the side screen fixing tube by means of the nut fitted at Operation 5.
12. Replace the rubber buffer.
13. Replace the door and sidescreen.
14. Repeat Operations 1—13 for the other door.
