THE ROVER COMPANY LIMITED
S E R V I C E D E P A R T M E N T

Rover Service News Letter No. 40

January 29th, 1954

TO ALL DISTRIBUTORS AND DEALERS

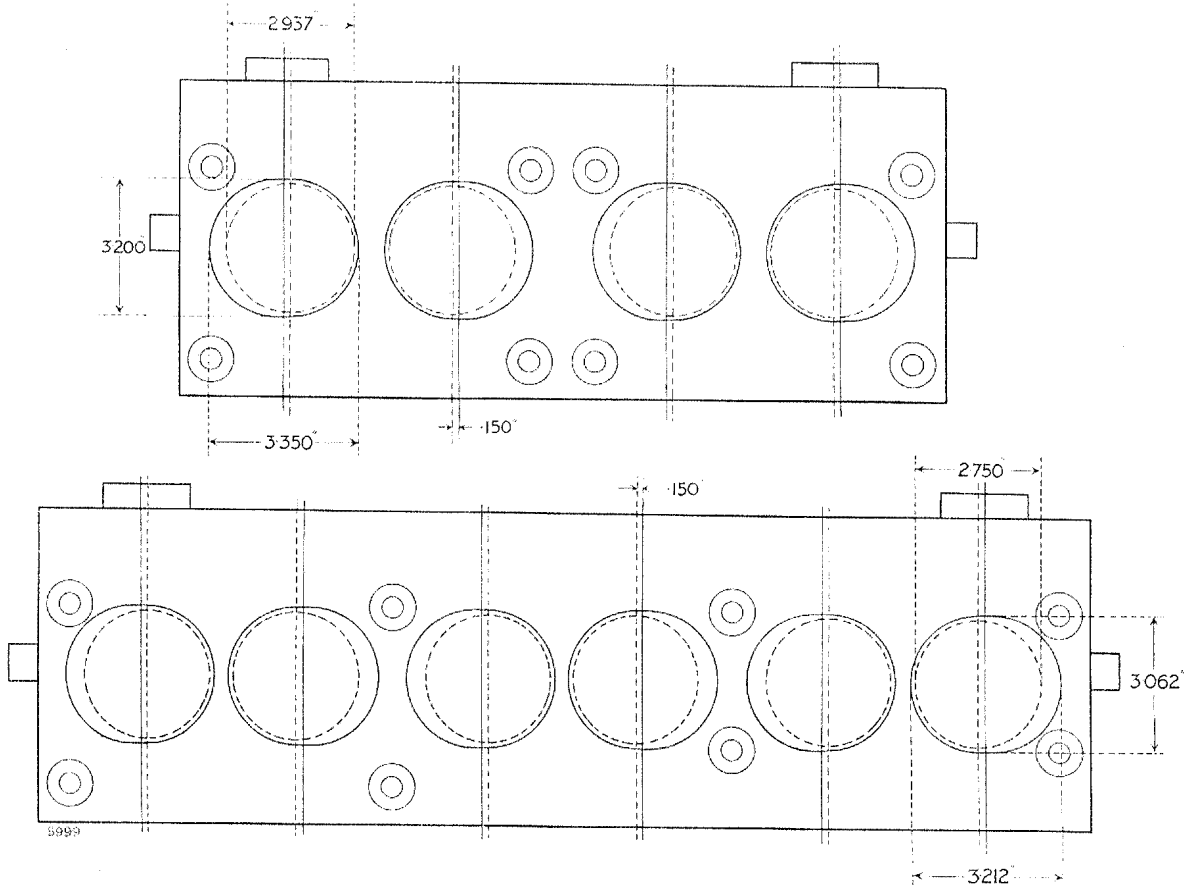
All Service stock of Jig blocks, part numbers 261287 and 261288, have been modified to make them suitable for the 1954 "60" and "75" and "90" respectively. Any stocks held by Distributors or Dealers can be modified as detailed in the sketch below, or alternatively they can be returned to our Service Department, where they will be modified free of charge.

Modification of Jig Block : Bore out, using scrap cylinder blocks to dimensions shown, elongating each bore by .150 in. (3,81 mm). Dotted lines indicate original bore size and centres. Heavy lines show new bore size and centres.

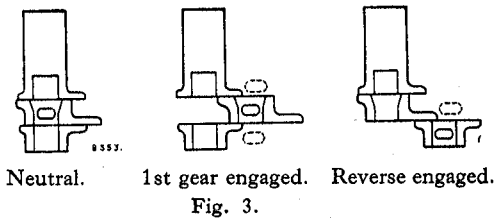
When a gear is selected, e.g. 1st gear, the main selector toggle can disengage from the 1st/2nd selector jaw and pass the "ear" of either the 3rd/4th or reverse jaw. Similarly, with reverse gear engaged the toggle can pass the ear of the 1st/2nd jaw.

At fig. 3 the incorrect positions of the toggle are shown by dotted lines.

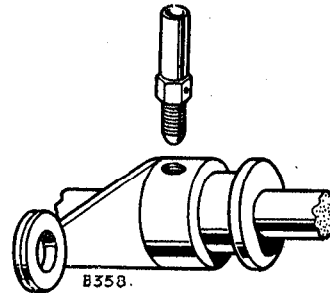
Fig. 6.

1. If the detent plunger body is not securely locked in the control tube lever, due to insufficient thread in the lever, the body can work loose and jam the plunger ball in the detent plate at the bottom of the steering column.

Increase the depth of tapping in the lever, tighten the plunger body and lock with iron wire.

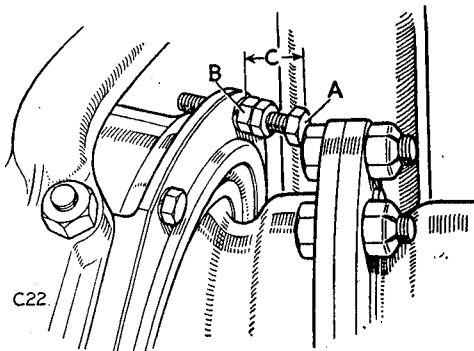
To improve the turning circle, from 50 ft. (15,25m) to 48-49 ft. (14,64-14,94m) on the Land-Rover 107 the solid block stop bolt has been replaced by an adjustable type bolt, Part No. 250698 with two locknuts, Part No. 2823, for each bolt.

Adjusting lock stop bolt.

This alteration has been incorporated from Vehicles numbered 47200002, 47230222 and 47260236 onwards. Any earlier vehicle can be modified by discarding the solid stop bolts and fitting two adjustable lock stop bolts and four locknuts. These should be adjusted to the dimension shown in the sketch. (86 dimension given for reference.)

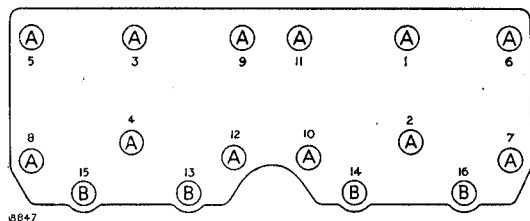
Order of tightening cylinder head bolts. "60".

When refitting the cylinder head it is **very important** to tighten the cylinder head bolts in accordance with the diagrams below.

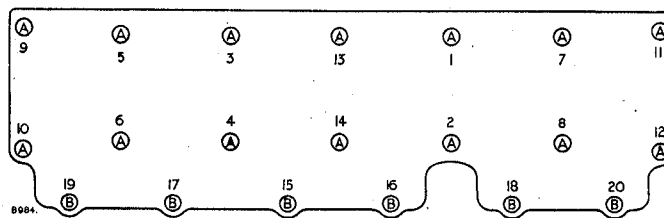
Order of tightening cylinder head bolts. "75" and "90".

Bolts "A". Tighten to 50 lbs. ft. (7 mKg.) torque.

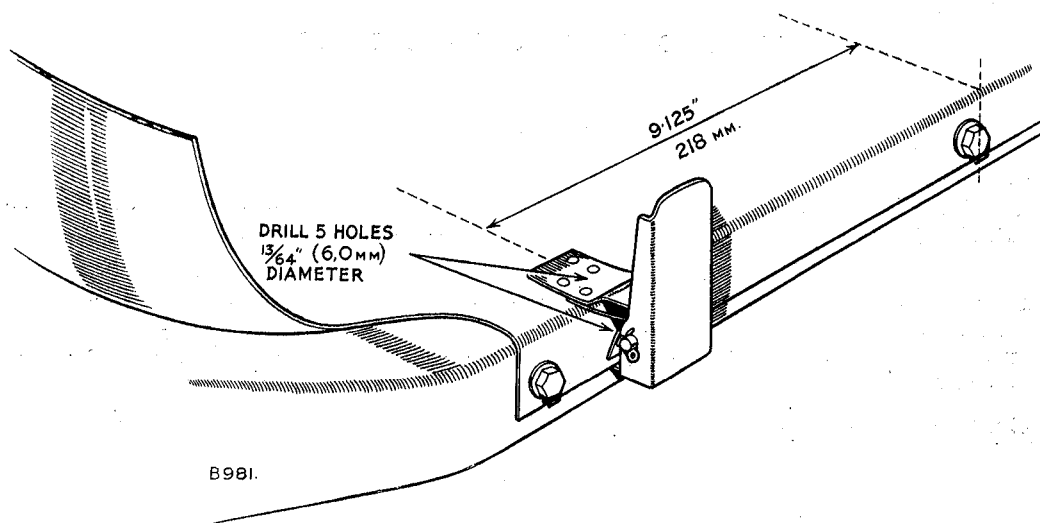
Position of safety catch on spare wheel housing.

Any earlier 1954 "60", "75" and "90" or 1952-53 "75" Car can be modified by fitting the Safety catch, using catch as a template, as shown in the sketch below. A complete kit of parts for this modification can be obtained from our Spares Dept. under Part No. 263156.

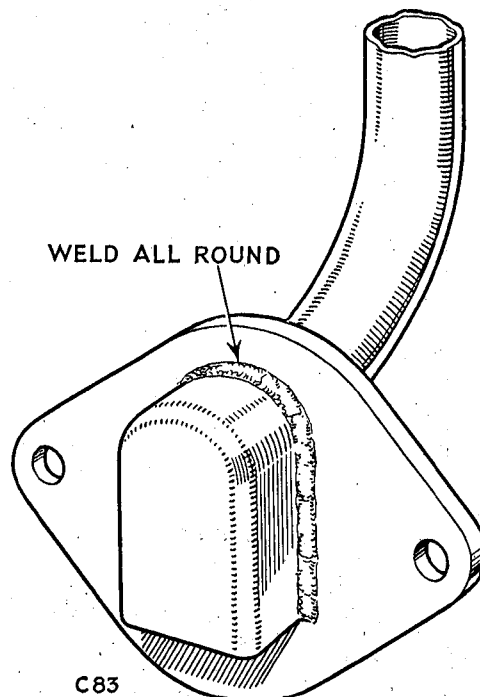
- Item 50 **OIL CONSUMPTION 1954 "90"** It has been found that the oil consumption on some "90" cars has increased after long high speed runs due to oil being thrown through the tack welding between the baffle plate and the cover plate into the oil breather pipe.

Fig. 1. Welding breather pipe baffle.

Where a complaint of high oil consumption after long runs is received, a check should be made in the vicinity of the breather pipe for traces of oil. If oil is found the breather pipe should be removed and the baffle welded all round as shown in the sketch below.

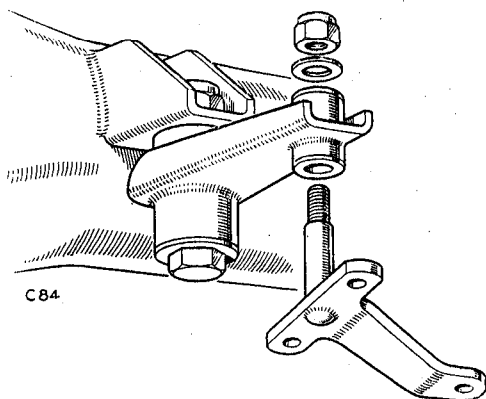
- Item 67** **SUBJECT:** Rear brakes.
MODELS: 1954 "60", "75" and "90".
COMPLAINT: Brakes binding, burning smell from brakes, oil on rear brake shoes.
CAUSE: Seizure of hand brake compensator pivot.
CURE: Dismantle and increase clearance between pin and bushes. On reassembly liberally apply grease to all working surfaces. From cars numbered as below, the pivot pin and lever have been redesigned to give more clearance and will be supplied as two separate items as shown at Fig. 2.
PART Nos. Balance lever: 1 263373.
Pivot pin: 1 263374.
COMM. Nos.: Cars numbered:—

Fig. 1. Early type brake compensator.

60: 43301650, 43330024, 43360034, 43630001, 43660033 onwards.
75: 44302642, 44330650, 44360504, 44730001, 44760017 onwards.
90: 45302174, 45330583, 45361286, 45830001, 45860017 onwards.
REMARKS: Only the latest type Balance lever and Pivot pin will be supplied for earlier 1954 models; they should be fitted as shown in the sketch below.

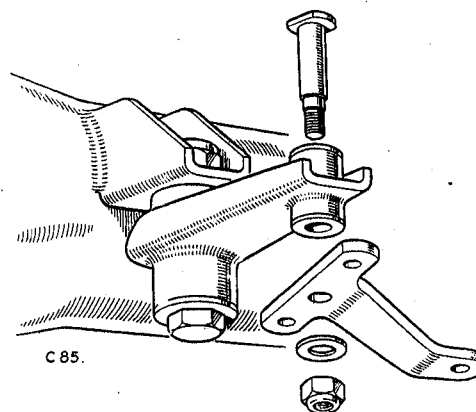
Fig. 2. Late type brake compensator.
