TECHNICAL INFORMATION

Rocker Arm Rattle/Tapping Sound

No: 12/02/00/NAS
Ref: WSM Section 12
Overhaul Manual
Replaces TIB 12/01/98/NAS
Issue: 2
Date: 12/22/00

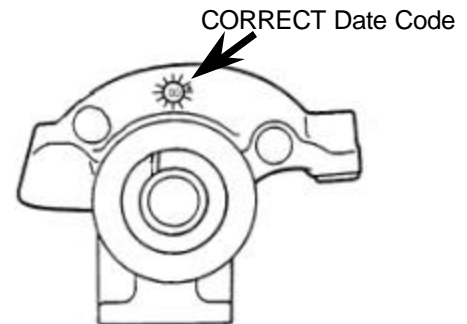
Figure 1

Customer complaints of a rattling/tapping noise from the engine found to originate from rocker shaft area may be the result of the hardened push-rod cup being insecure in the rocker arm.

CAUTION: Only rocker arms with date codes '00' may be used to repair valve trains. Use of early production rocker arms may result in a reoccurrence of the problem.

4. Refer to Overhaul Manual LRL0004ENG and replace all rocker arms manufactured prior to a '00' date code with new rocker arms having date code '00' or above. (Figure 1)
5. Assemble and install rocker arm assemblies.
6. Install rocker arm covers.
7. Start the engine and confirm that the rattling/tapping noise has been resolved.
