TECHNICAL INFORMATION

Revised Labor Time for Front Propeller Shaft Replacement

No: 47/02/05/NAS
FGN 205-01
Ref:
Issue: 1
Date: 26 September 2005

Discovery Series II (LT) All

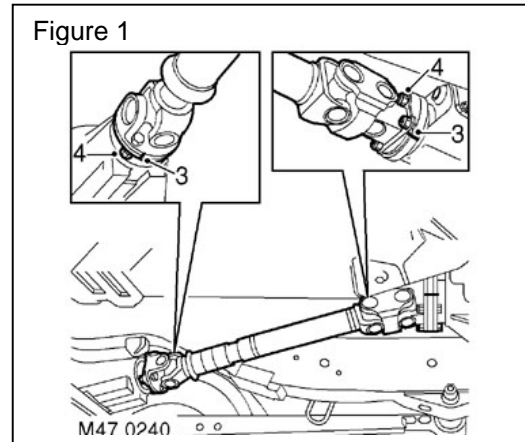
REPLACE FRONT PROPELLER SHAFT

1. Refer to GTR Workshop Manual Section 47.15.02 and replace front propeller shaft. (Figure 1)
