TECHNICAL INFORMATION

No: 51/02/00/NAS
 Ref: 51/01/98/NAS
 Issue: 1
 Date: 05/12/00

Click Noise from Rear Axle Area

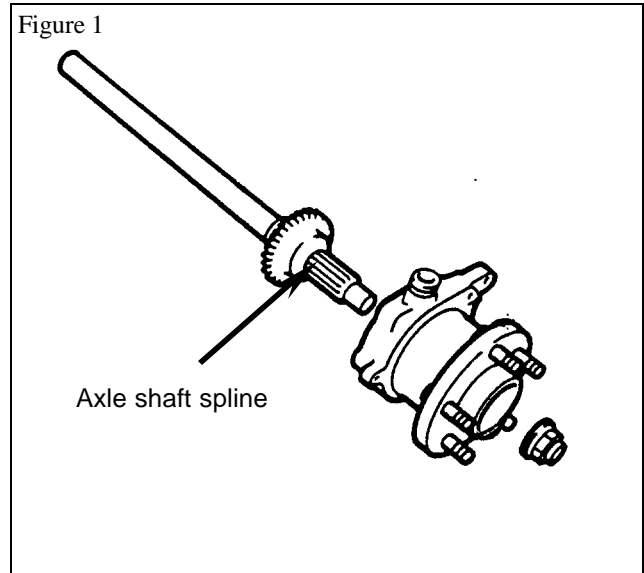
When moving the gear selector lever from the "D" (drive) position to "R" (reverse) or from "R" to "D", a clicking noise may be heard from the rear axle area. The noise may be the result of movement between the axle shaft spline and the drive flange. The differential flange to pinion spline can exhibit the same symptoms.

4. Apply Loctite® 648 to the shaft spline taking care not to coat beyond the spline area. (Figure 1)
5. Reassemble shaft to flange assembly.
6. Install new stake-nut (CDU1534).
7. Tighten the nut to initial torque of **100 Nm (75lbf. ft.)**.

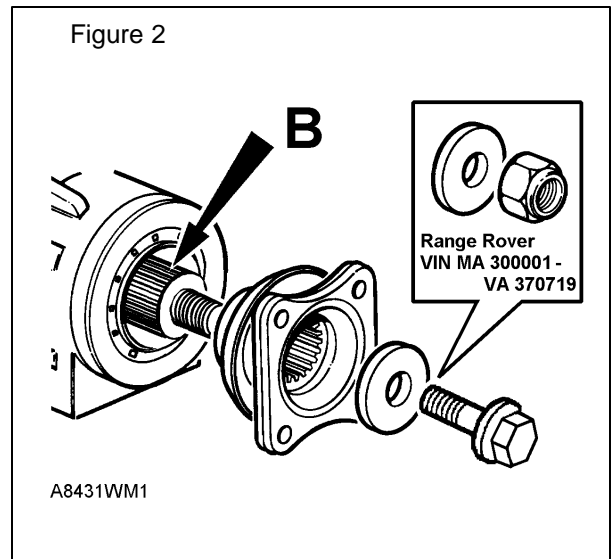
CAUTION: Range Rover vehicles up to VIN VA370719 have pinion flanges secured with a nut. Later vehicles use a flange bolt, (refer to Figure 2). It is essential that each fastener type be tightened to the correct torque as specified below.

3. Apply Loctite 648 to the pinion shaft spline ensuring that only the spline area is coated. ('B' in Figure 2)

4. If pinion flange is secured by a bolt, install flange and tighten the bolt to **100Nm (73.8 lbf.ft.)**.
5. If pinion flange is secured with a nut, install flange and tighten the nut to **135Nm (99.5 lbf.ft.)**.
6. Allow 2 hours for the Loctite to cure before driving vehicle.
