# TECHNICAL INFORMATION

No: 54/02/03/NAS  
Ref:  
Issue: 1  
Date: 03/07/03

## Driveline Vibration Troubleshooting

Discovery Series II (LT)

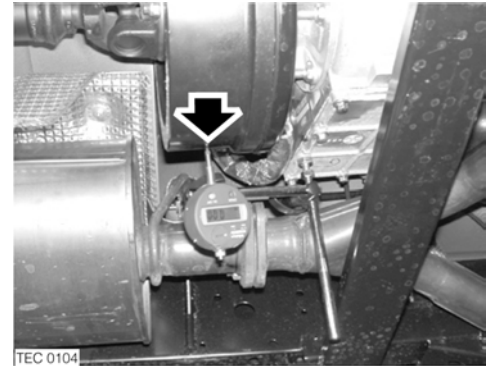
Figure 1

10. Position a Dial Test Indicator to the handbrake drum and zero the DTI (Figure 1).
11. Rotate the drum through one full revolution stopping at 90° intervals and note the radial run out at these points. (Arrowed in Figure 2)

12. If the run out exceeds 0.10 mm (0.004 in) at any point around the handbrake drum, perform the following:
  - Locate the noted high point on the circumference of the brake drum.

- Tap carefully with a Nylon mallet to minimize the run out.
13. Measure the handbrake drum run out again to ensure it is now within tolerance.
14. Tighten the nuts securing the propeller shaft universal joint to the handbrake drum to **48 Nm (35 lbf.ft.)**.

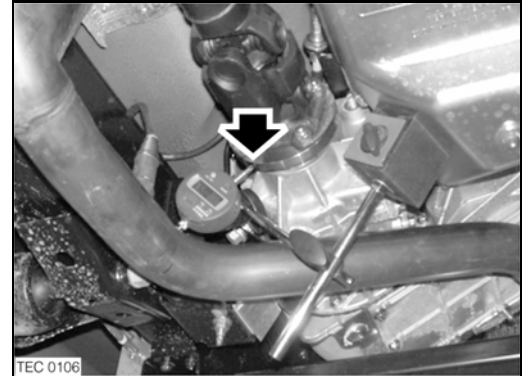
Figure 3

3. Clean the circumference of the transfer gearbox front output drive flange.
4. Position a DTI to the transfer gearbox front output drive flange and reset the DTI to zero (Figure 3).

5. Rotate the propeller shaft one full revolution and note the run out of the flange.
6. If the run out exceeds 0.10 mm (0.004 in), refer to RAVE section 41.20.51 and replace the transfer gearbox front output drive flange with a new component.

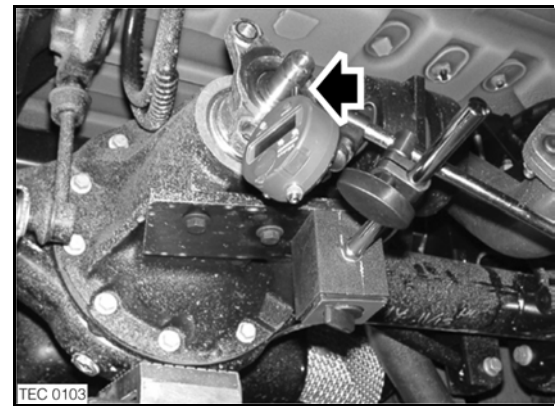
Figure 4

18. Position a DTI to the rear propeller shaft-centering peg and zero the DTI. (Figure 4).
19. Rotate a rear road wheel and note the run out of the rear propeller shaft-centering peg.

20. If the run out exceeds 0.10 mm (0.004"), refer to RAVE section 51.20.01 to remove and rotate the flange 180° from its original location.
21. Check the run out after 180-degree rotation.

22. If the run out exceeds 0.10 mm (0.004") refer to RAVE section 51.20.01 and replace the centralizing peg and the rear differential input drive flange with new components.
